### A Field 3D acquisition (non-destructive)

Intel RealSense D455  
Non-contact 3D scanning of worn stone staircase

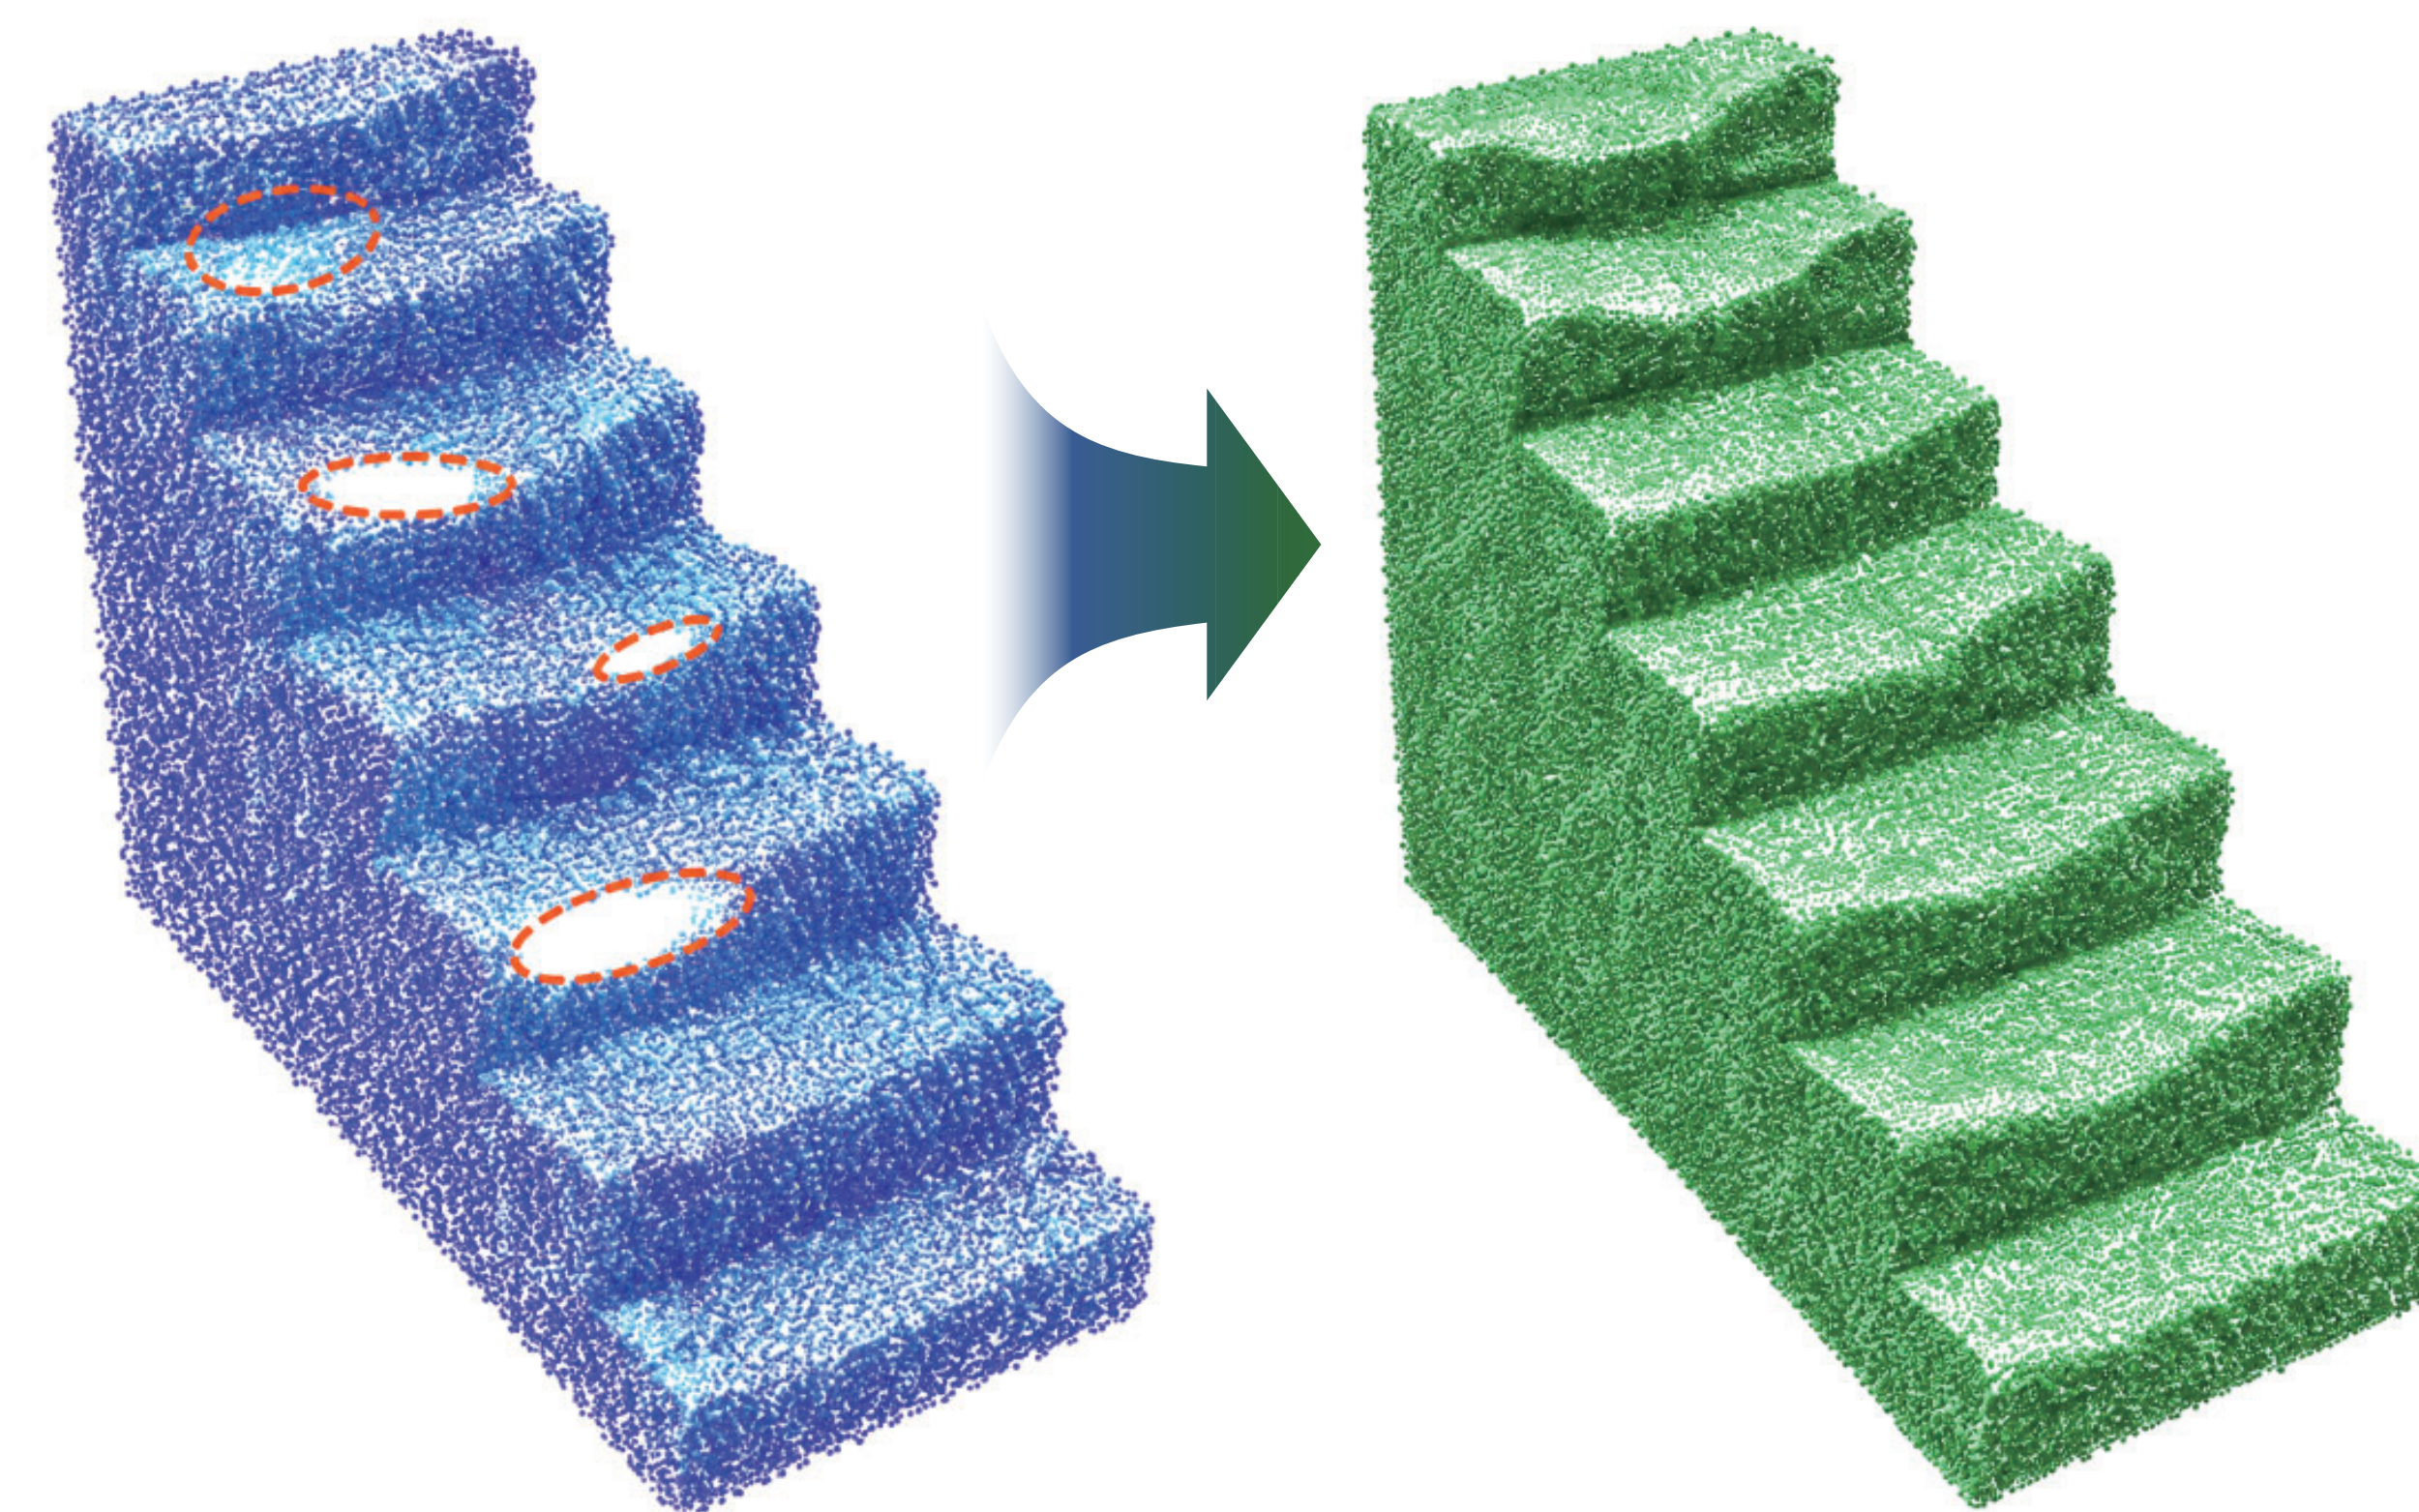
### D Missing-region completion

Incomplete point cloud (with missing regions)      Completed point cloud (interpolated)

Missing region      Interpolated region

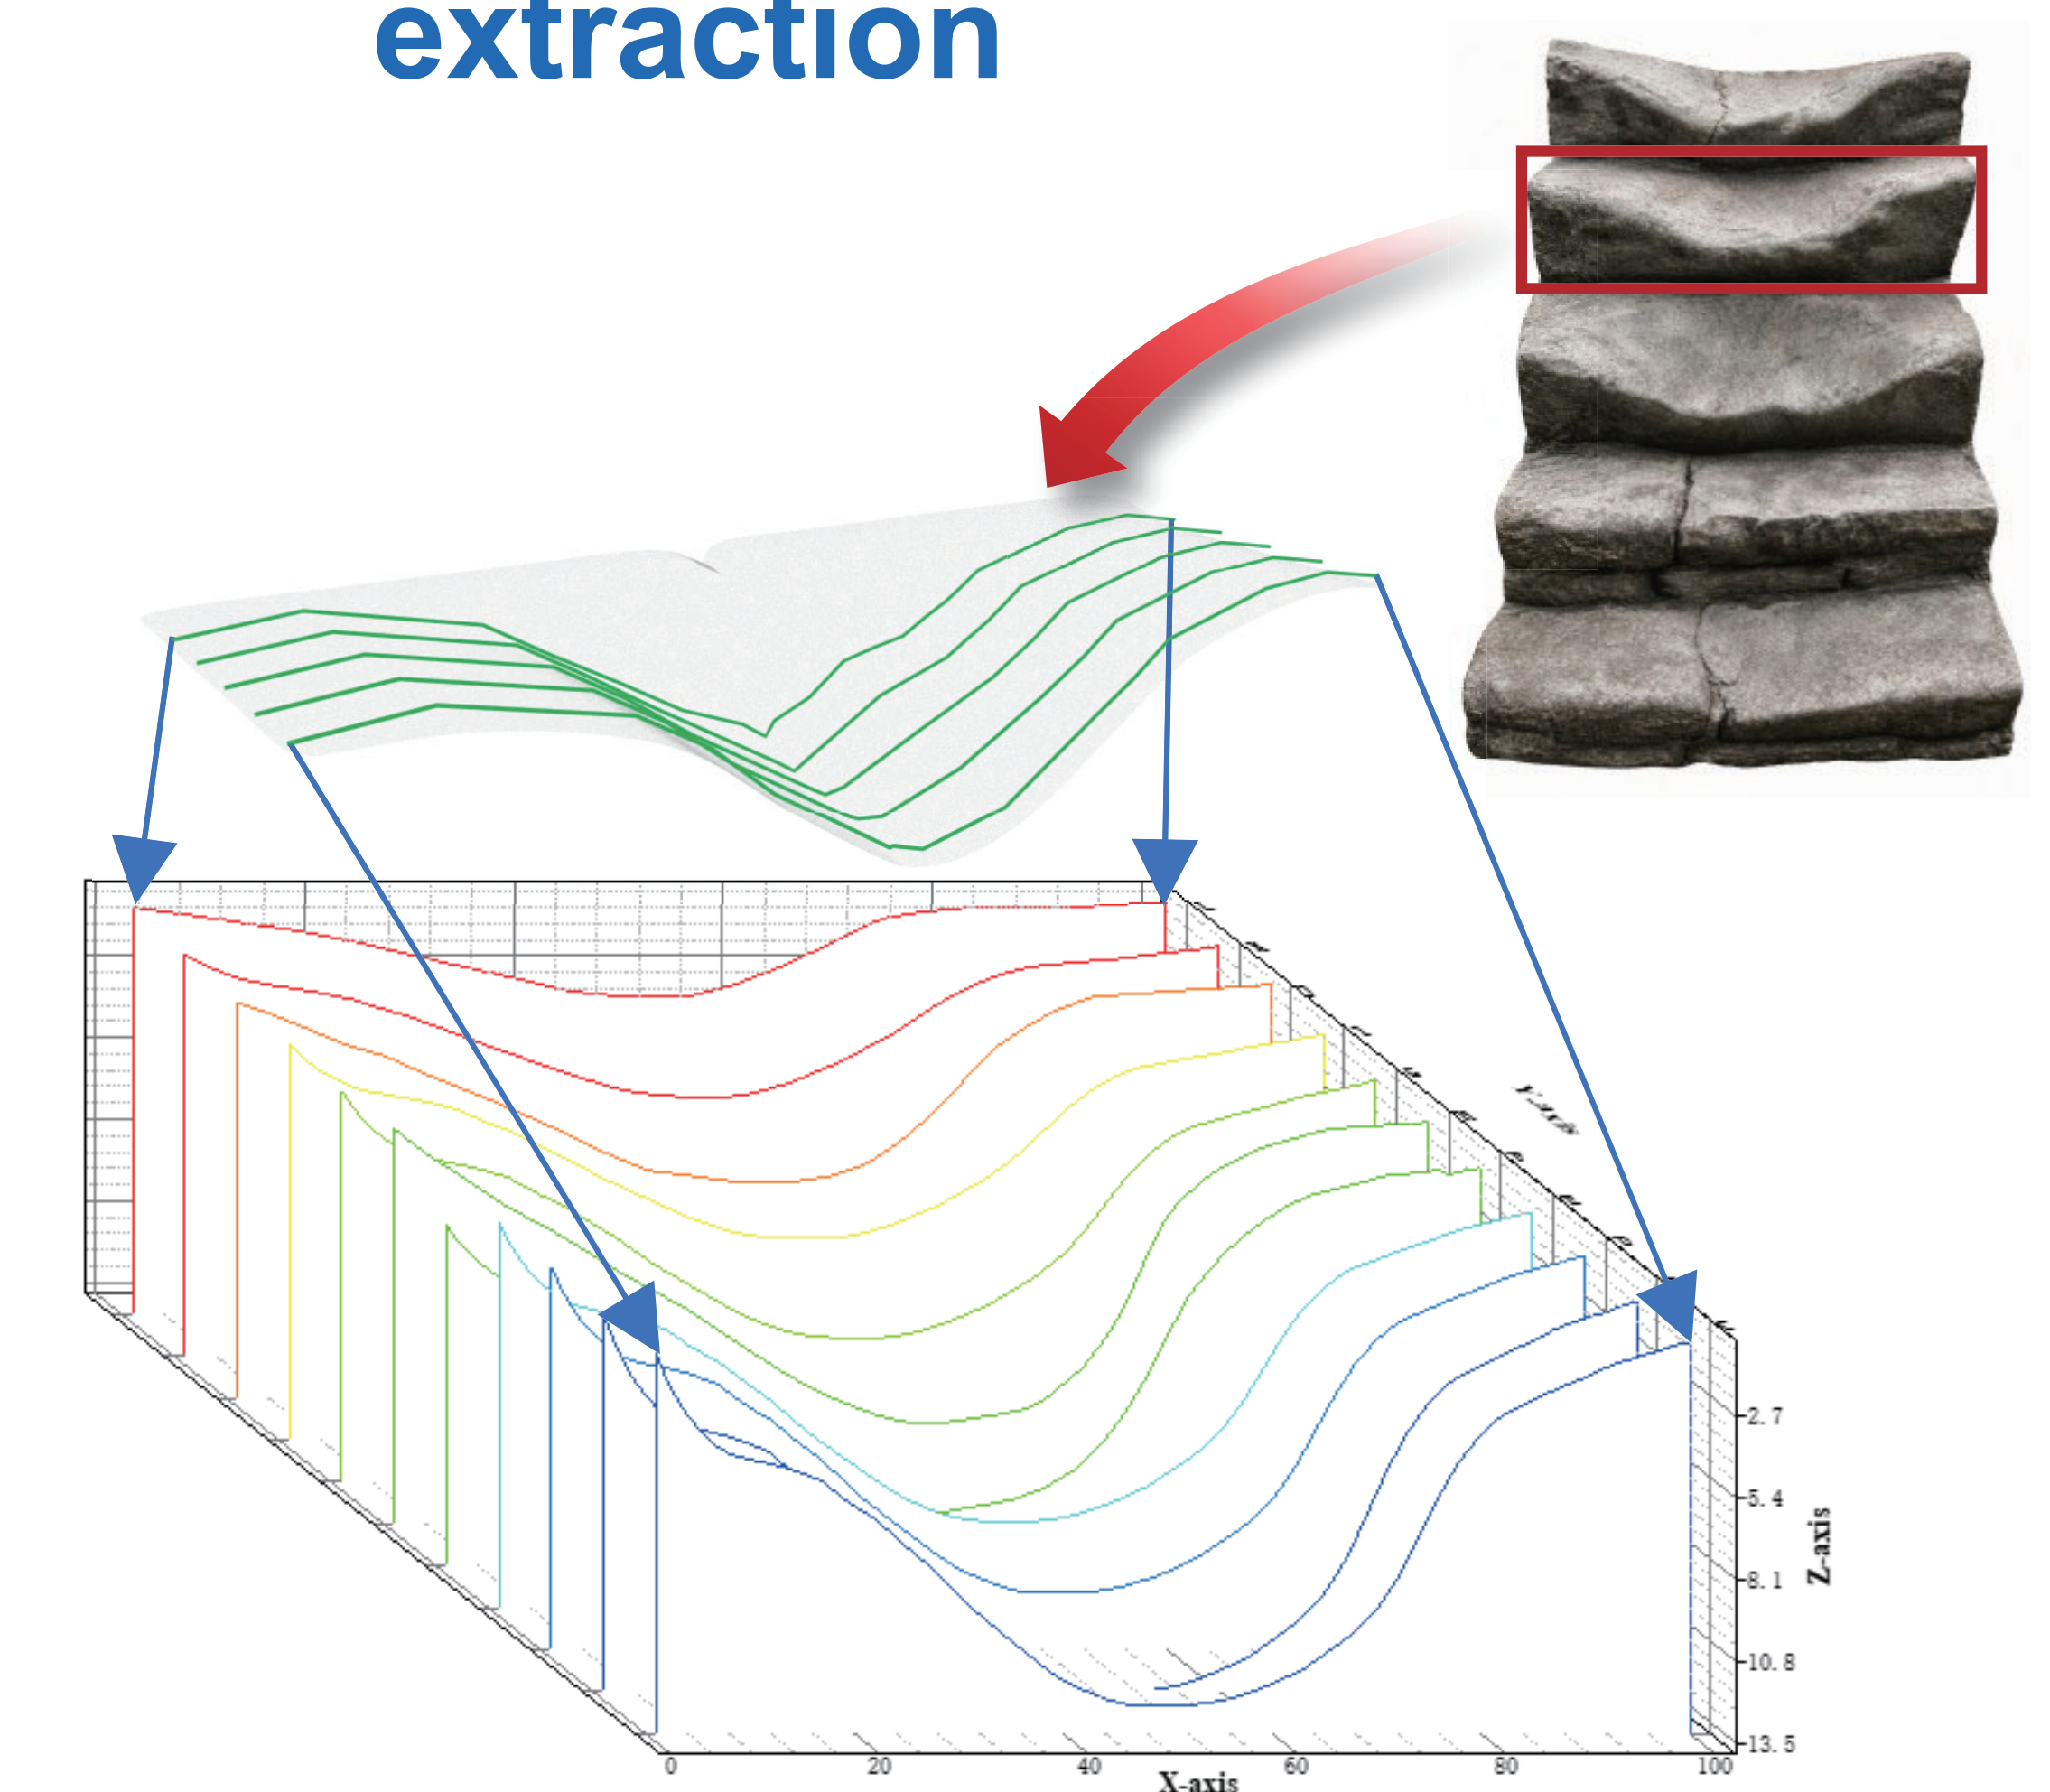
### F Morphometric parameter extraction

Longitudinal x-z profile (averaged)
