### Weathered irregular stone steps

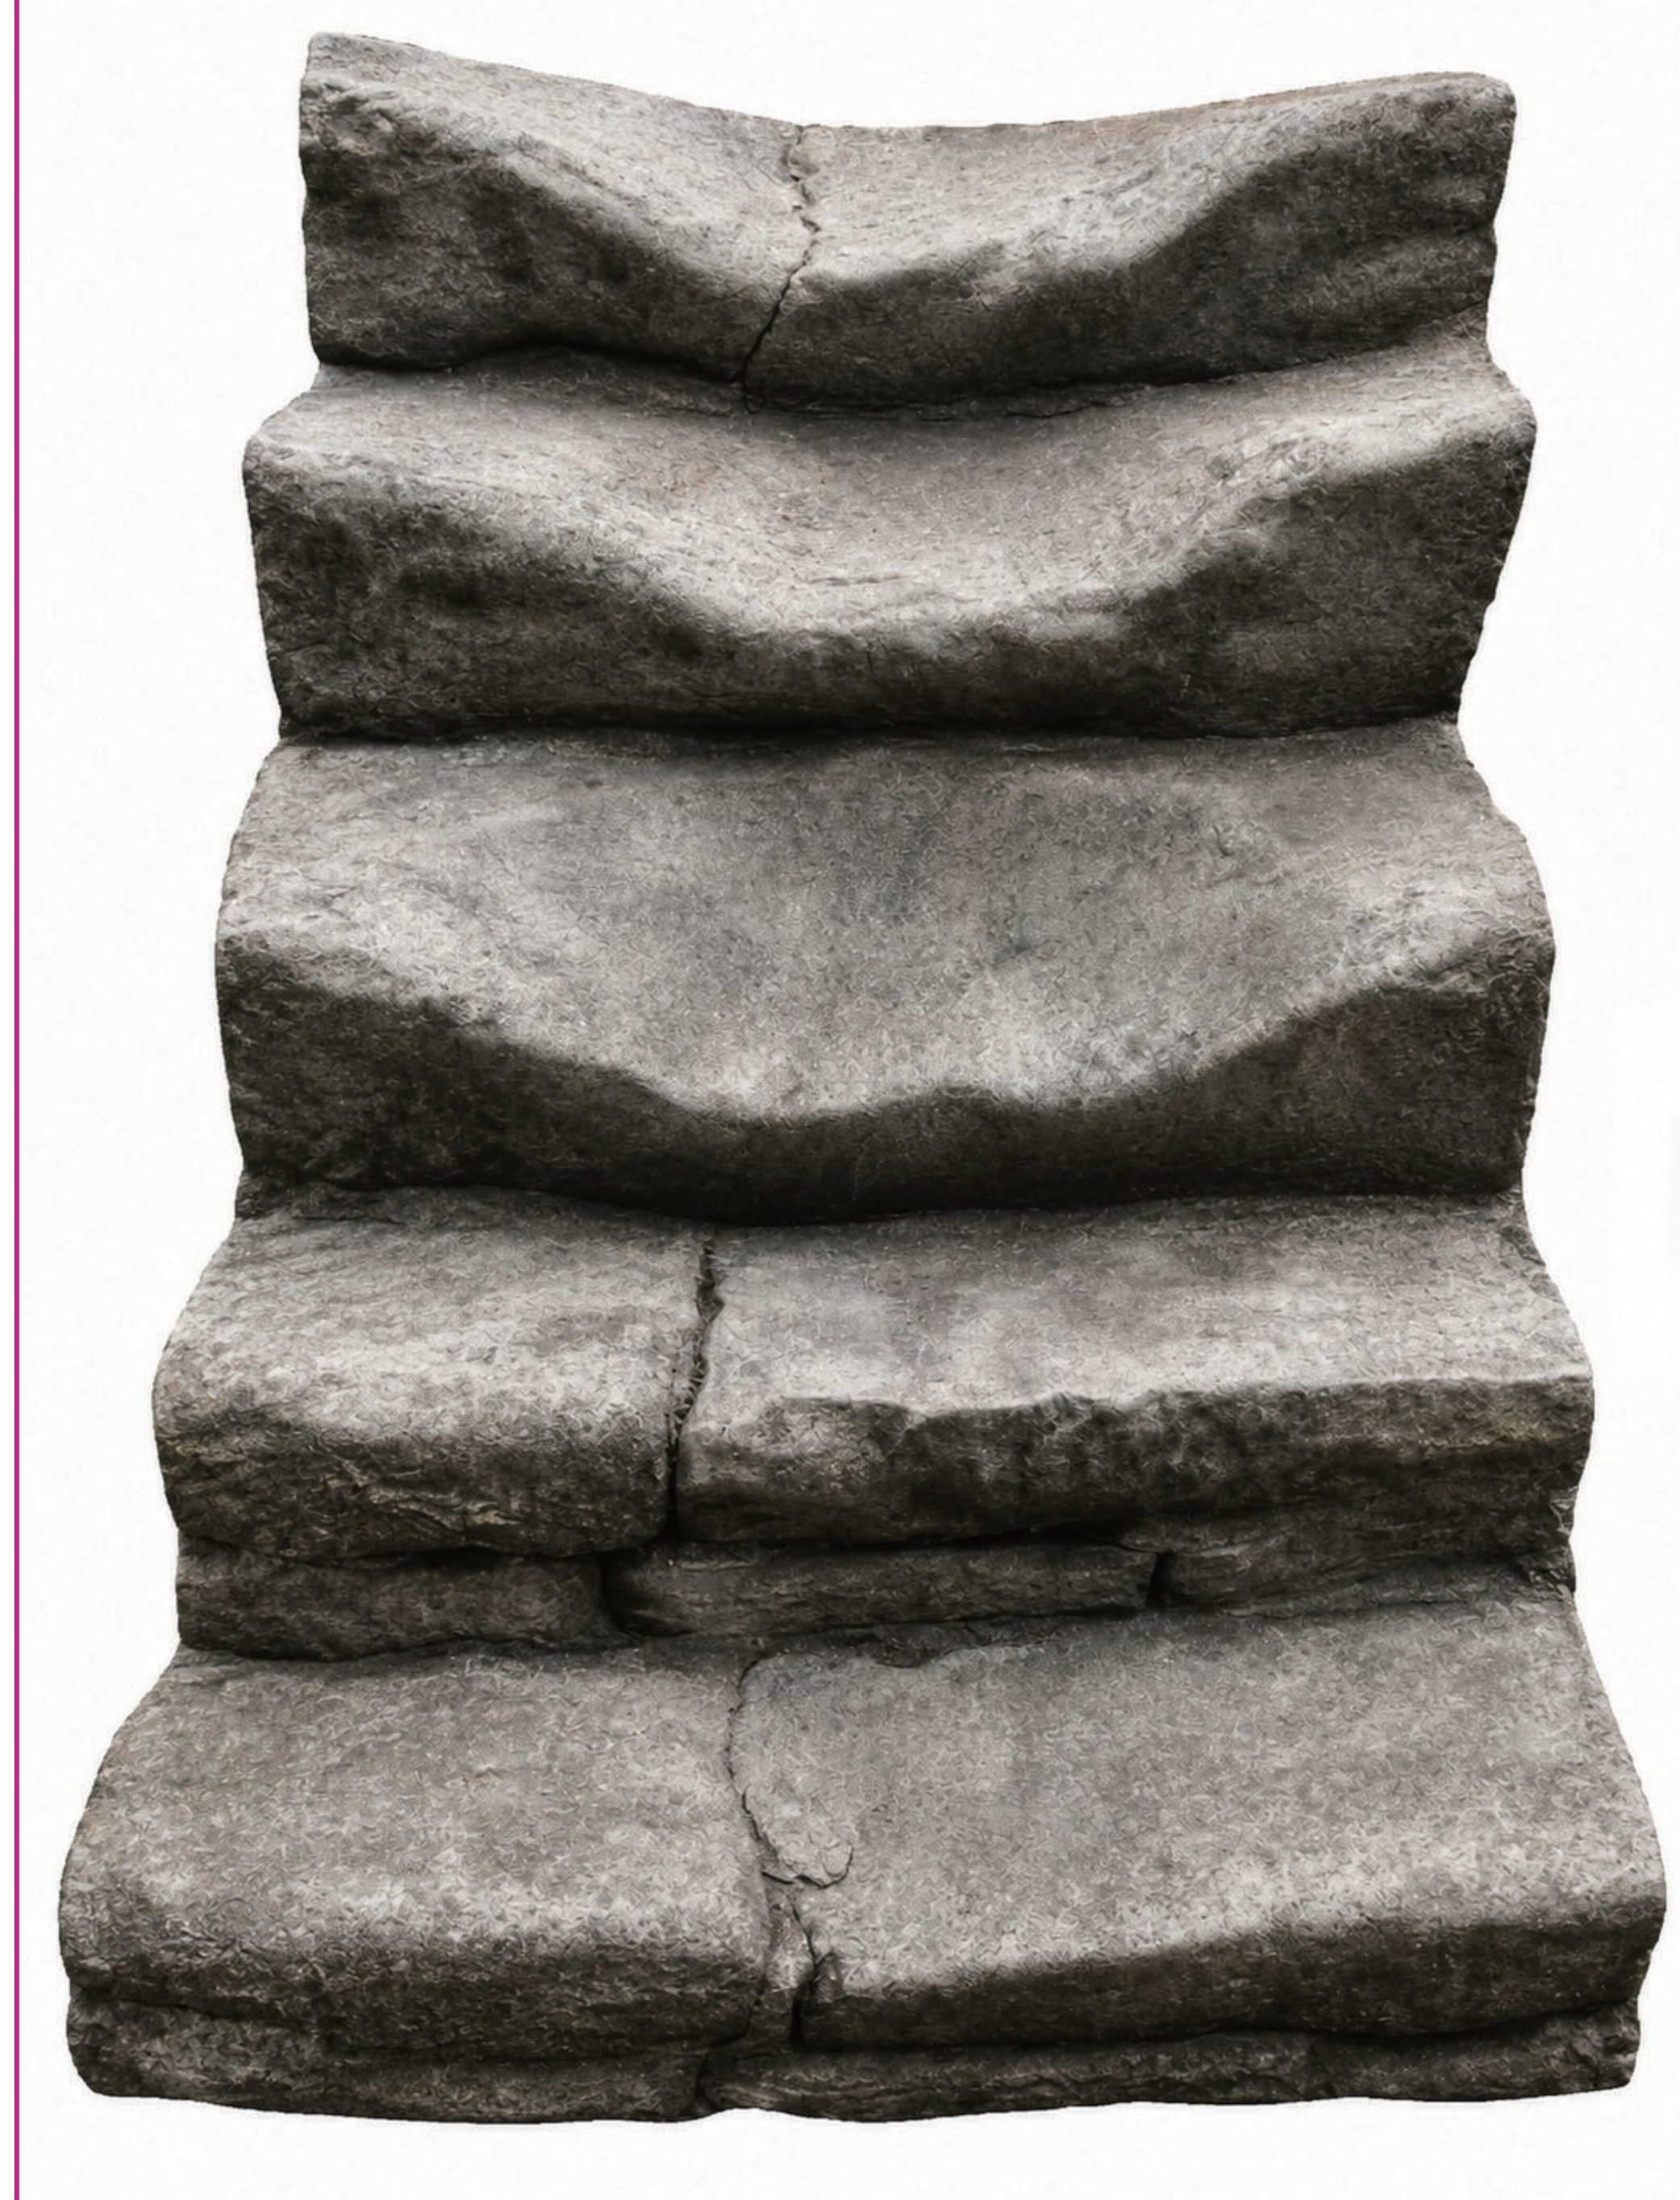
Staircase Number: No.1

Original image

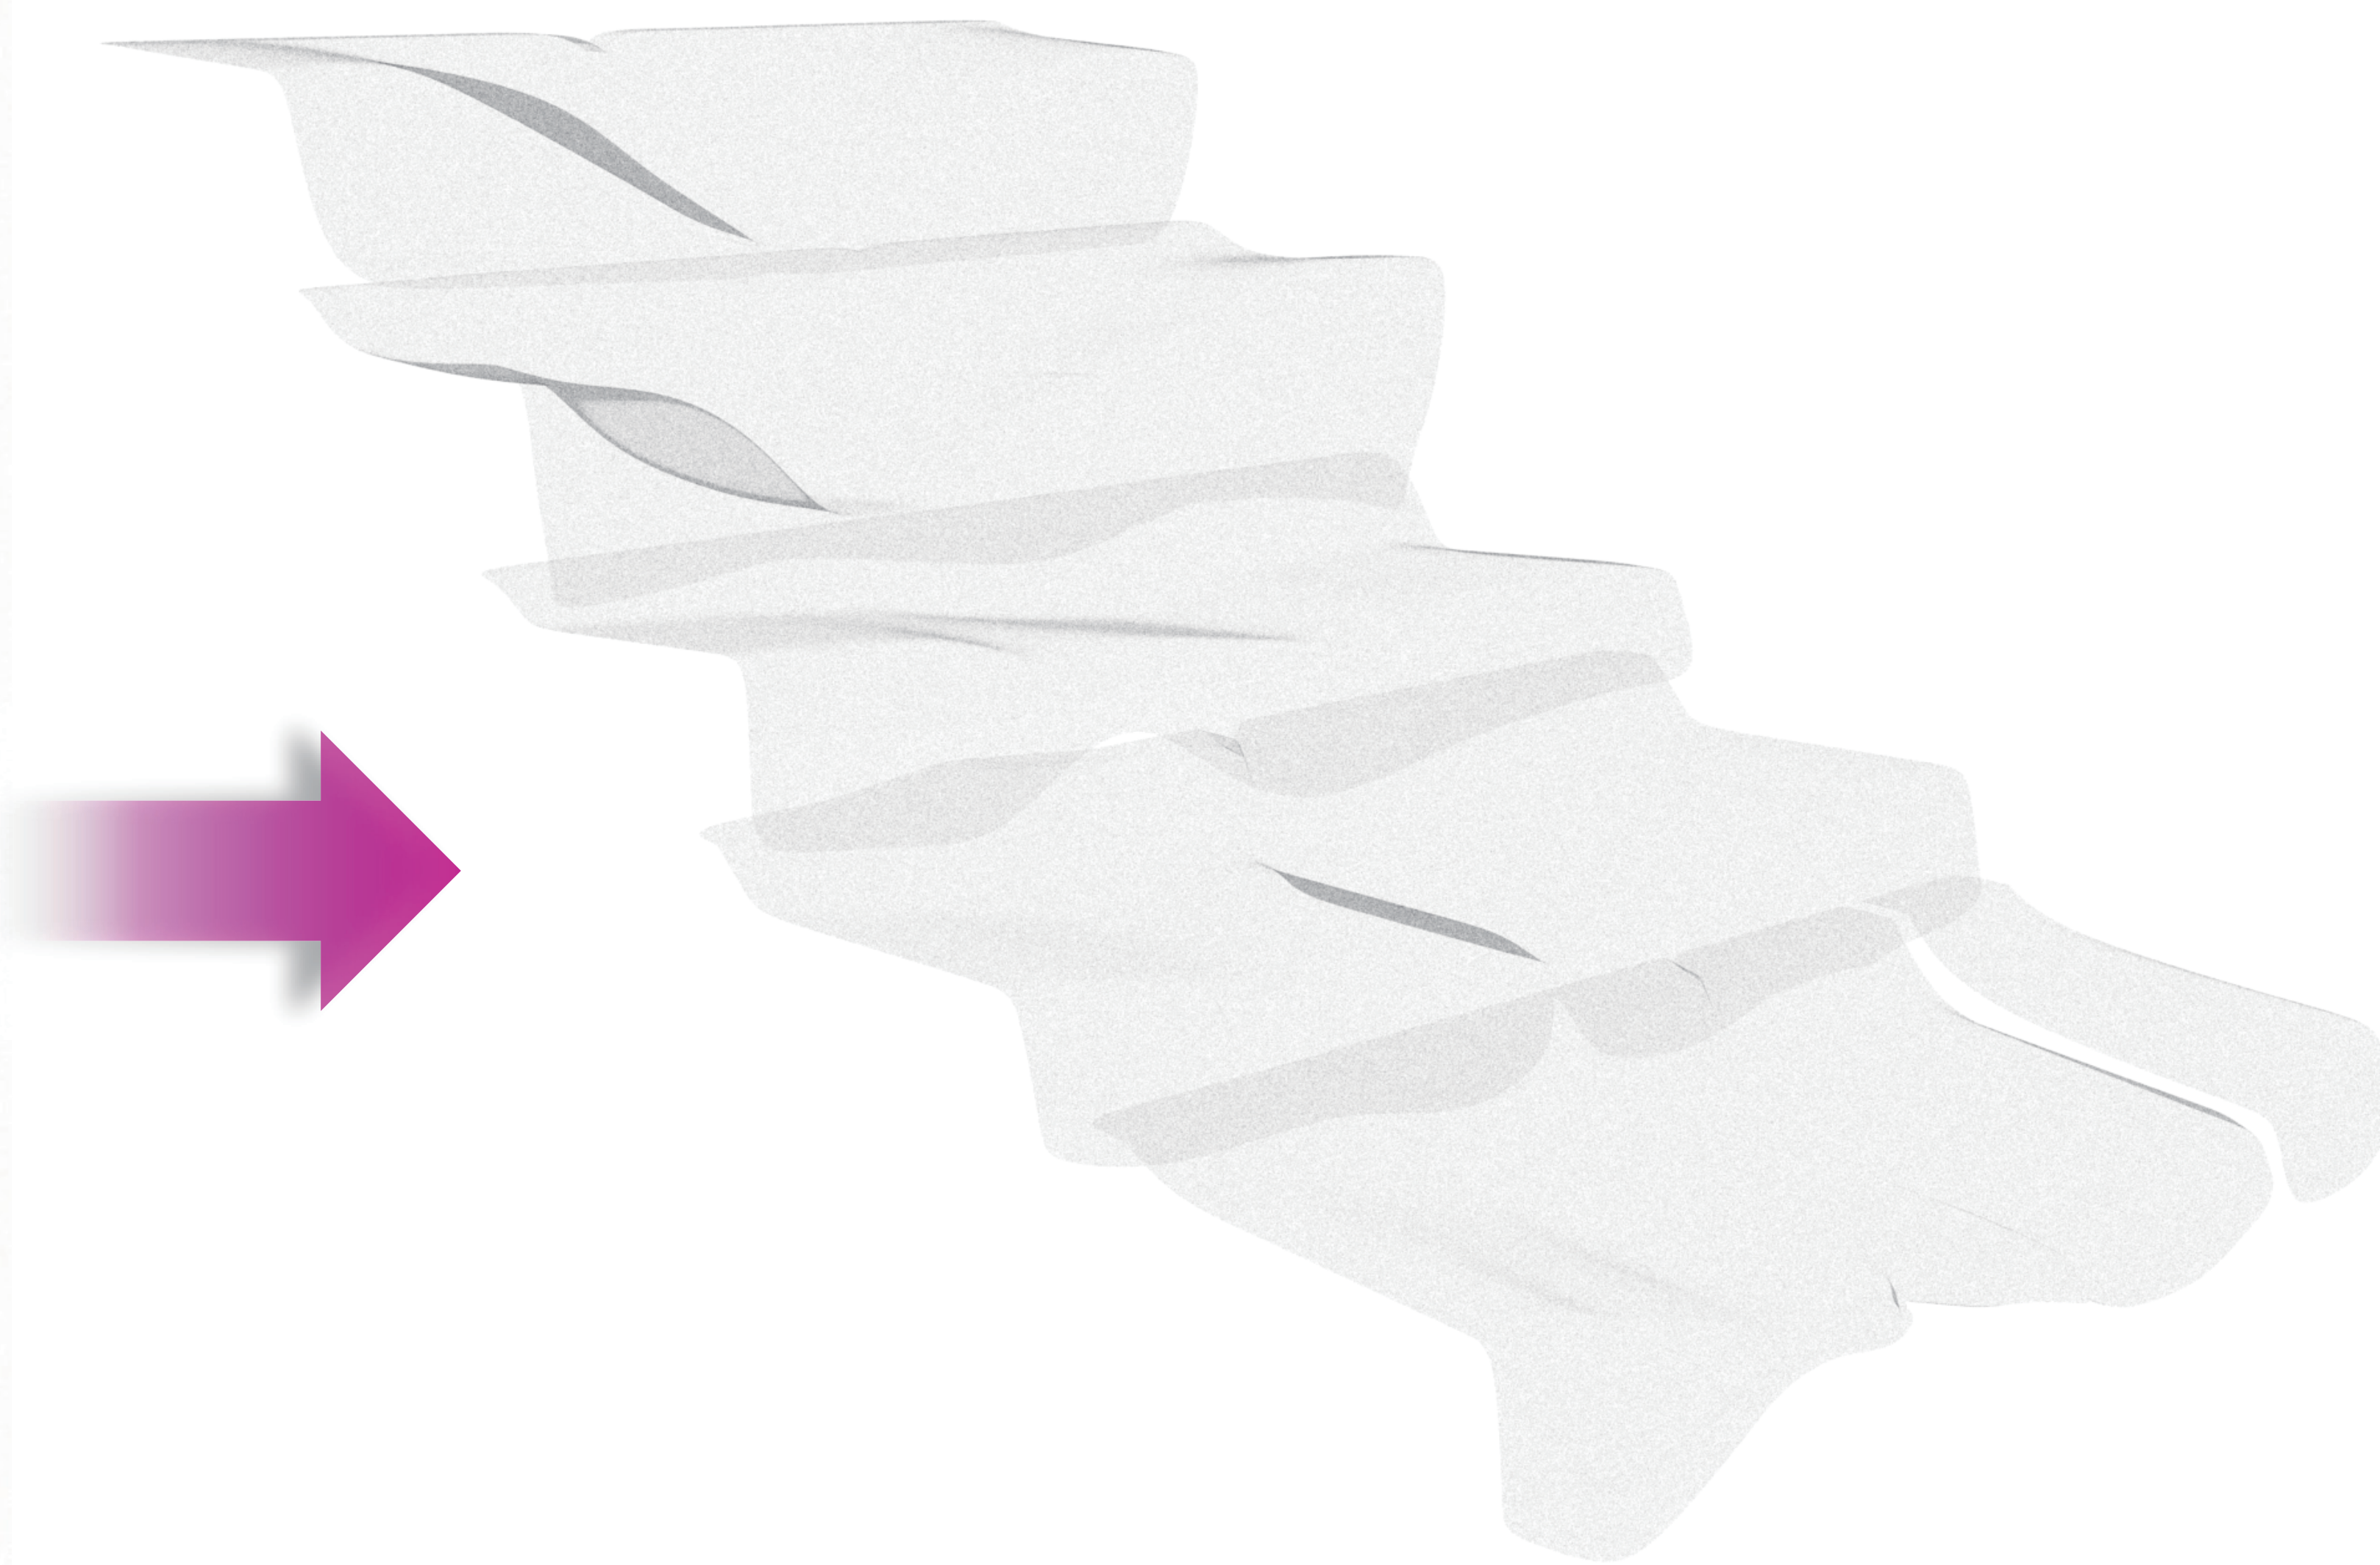
3D point-cloud scan

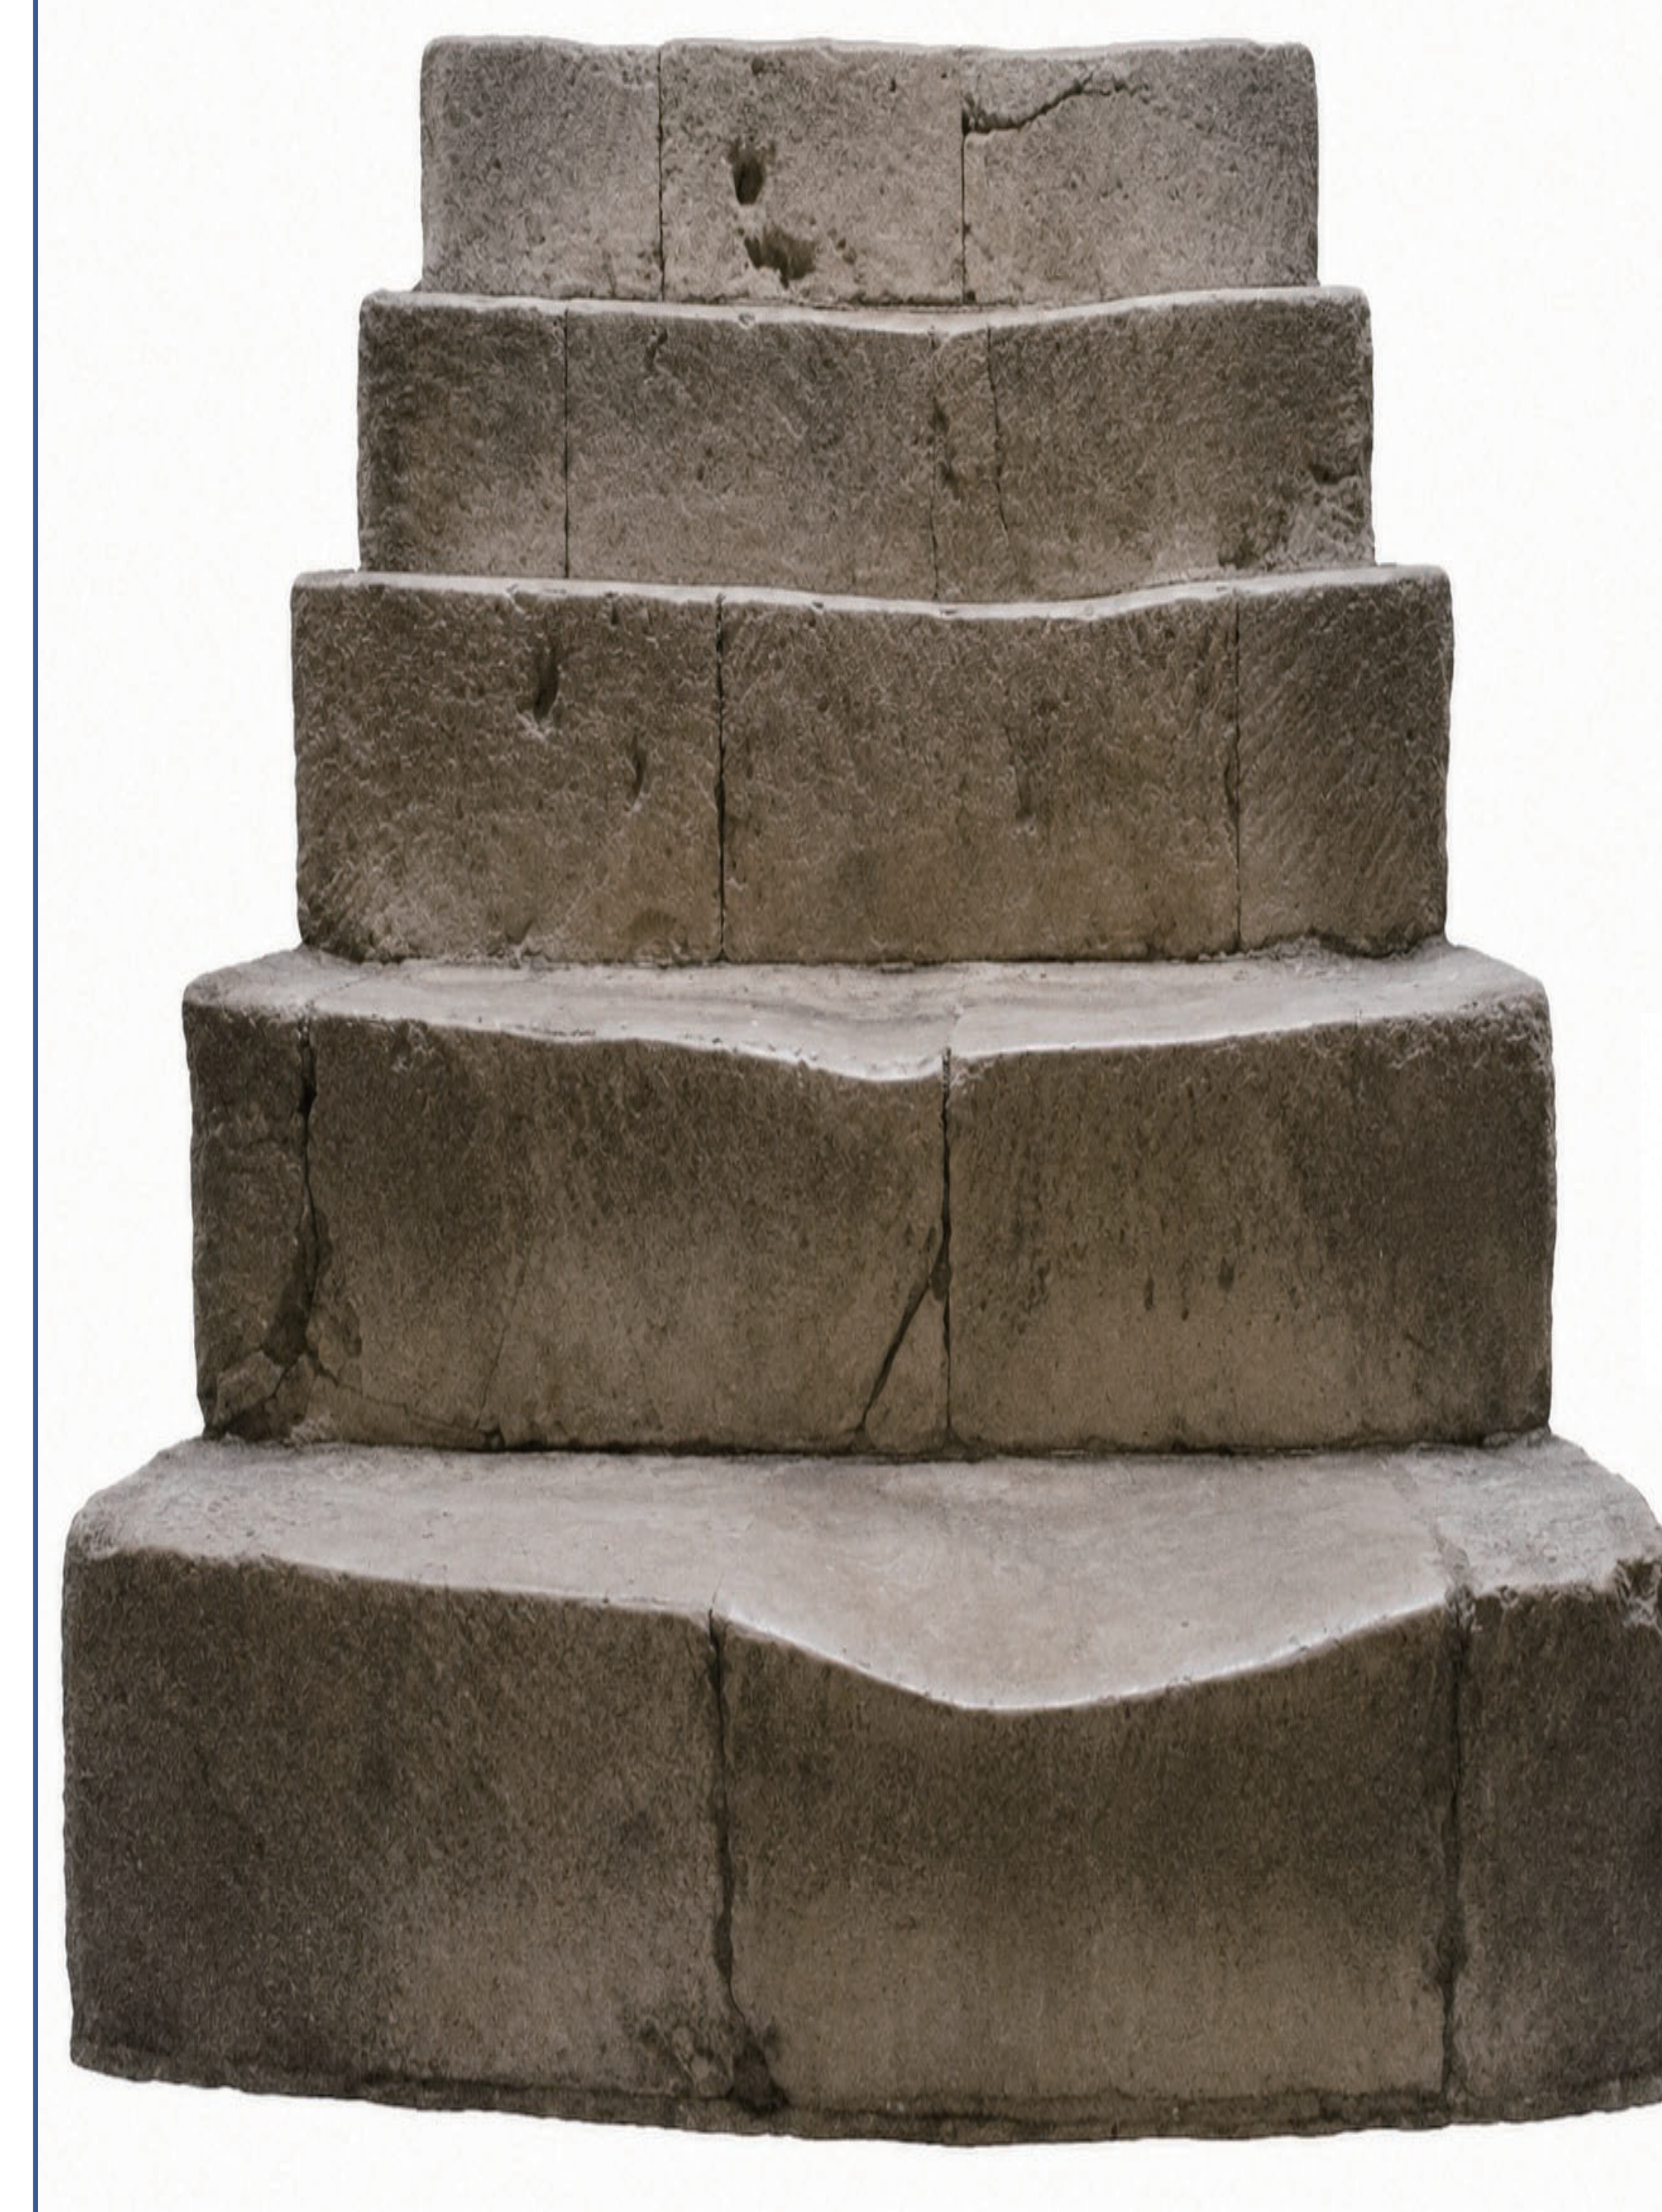
Staircase Number: No.2

### Narrow confined stairway with worn treads

Original image

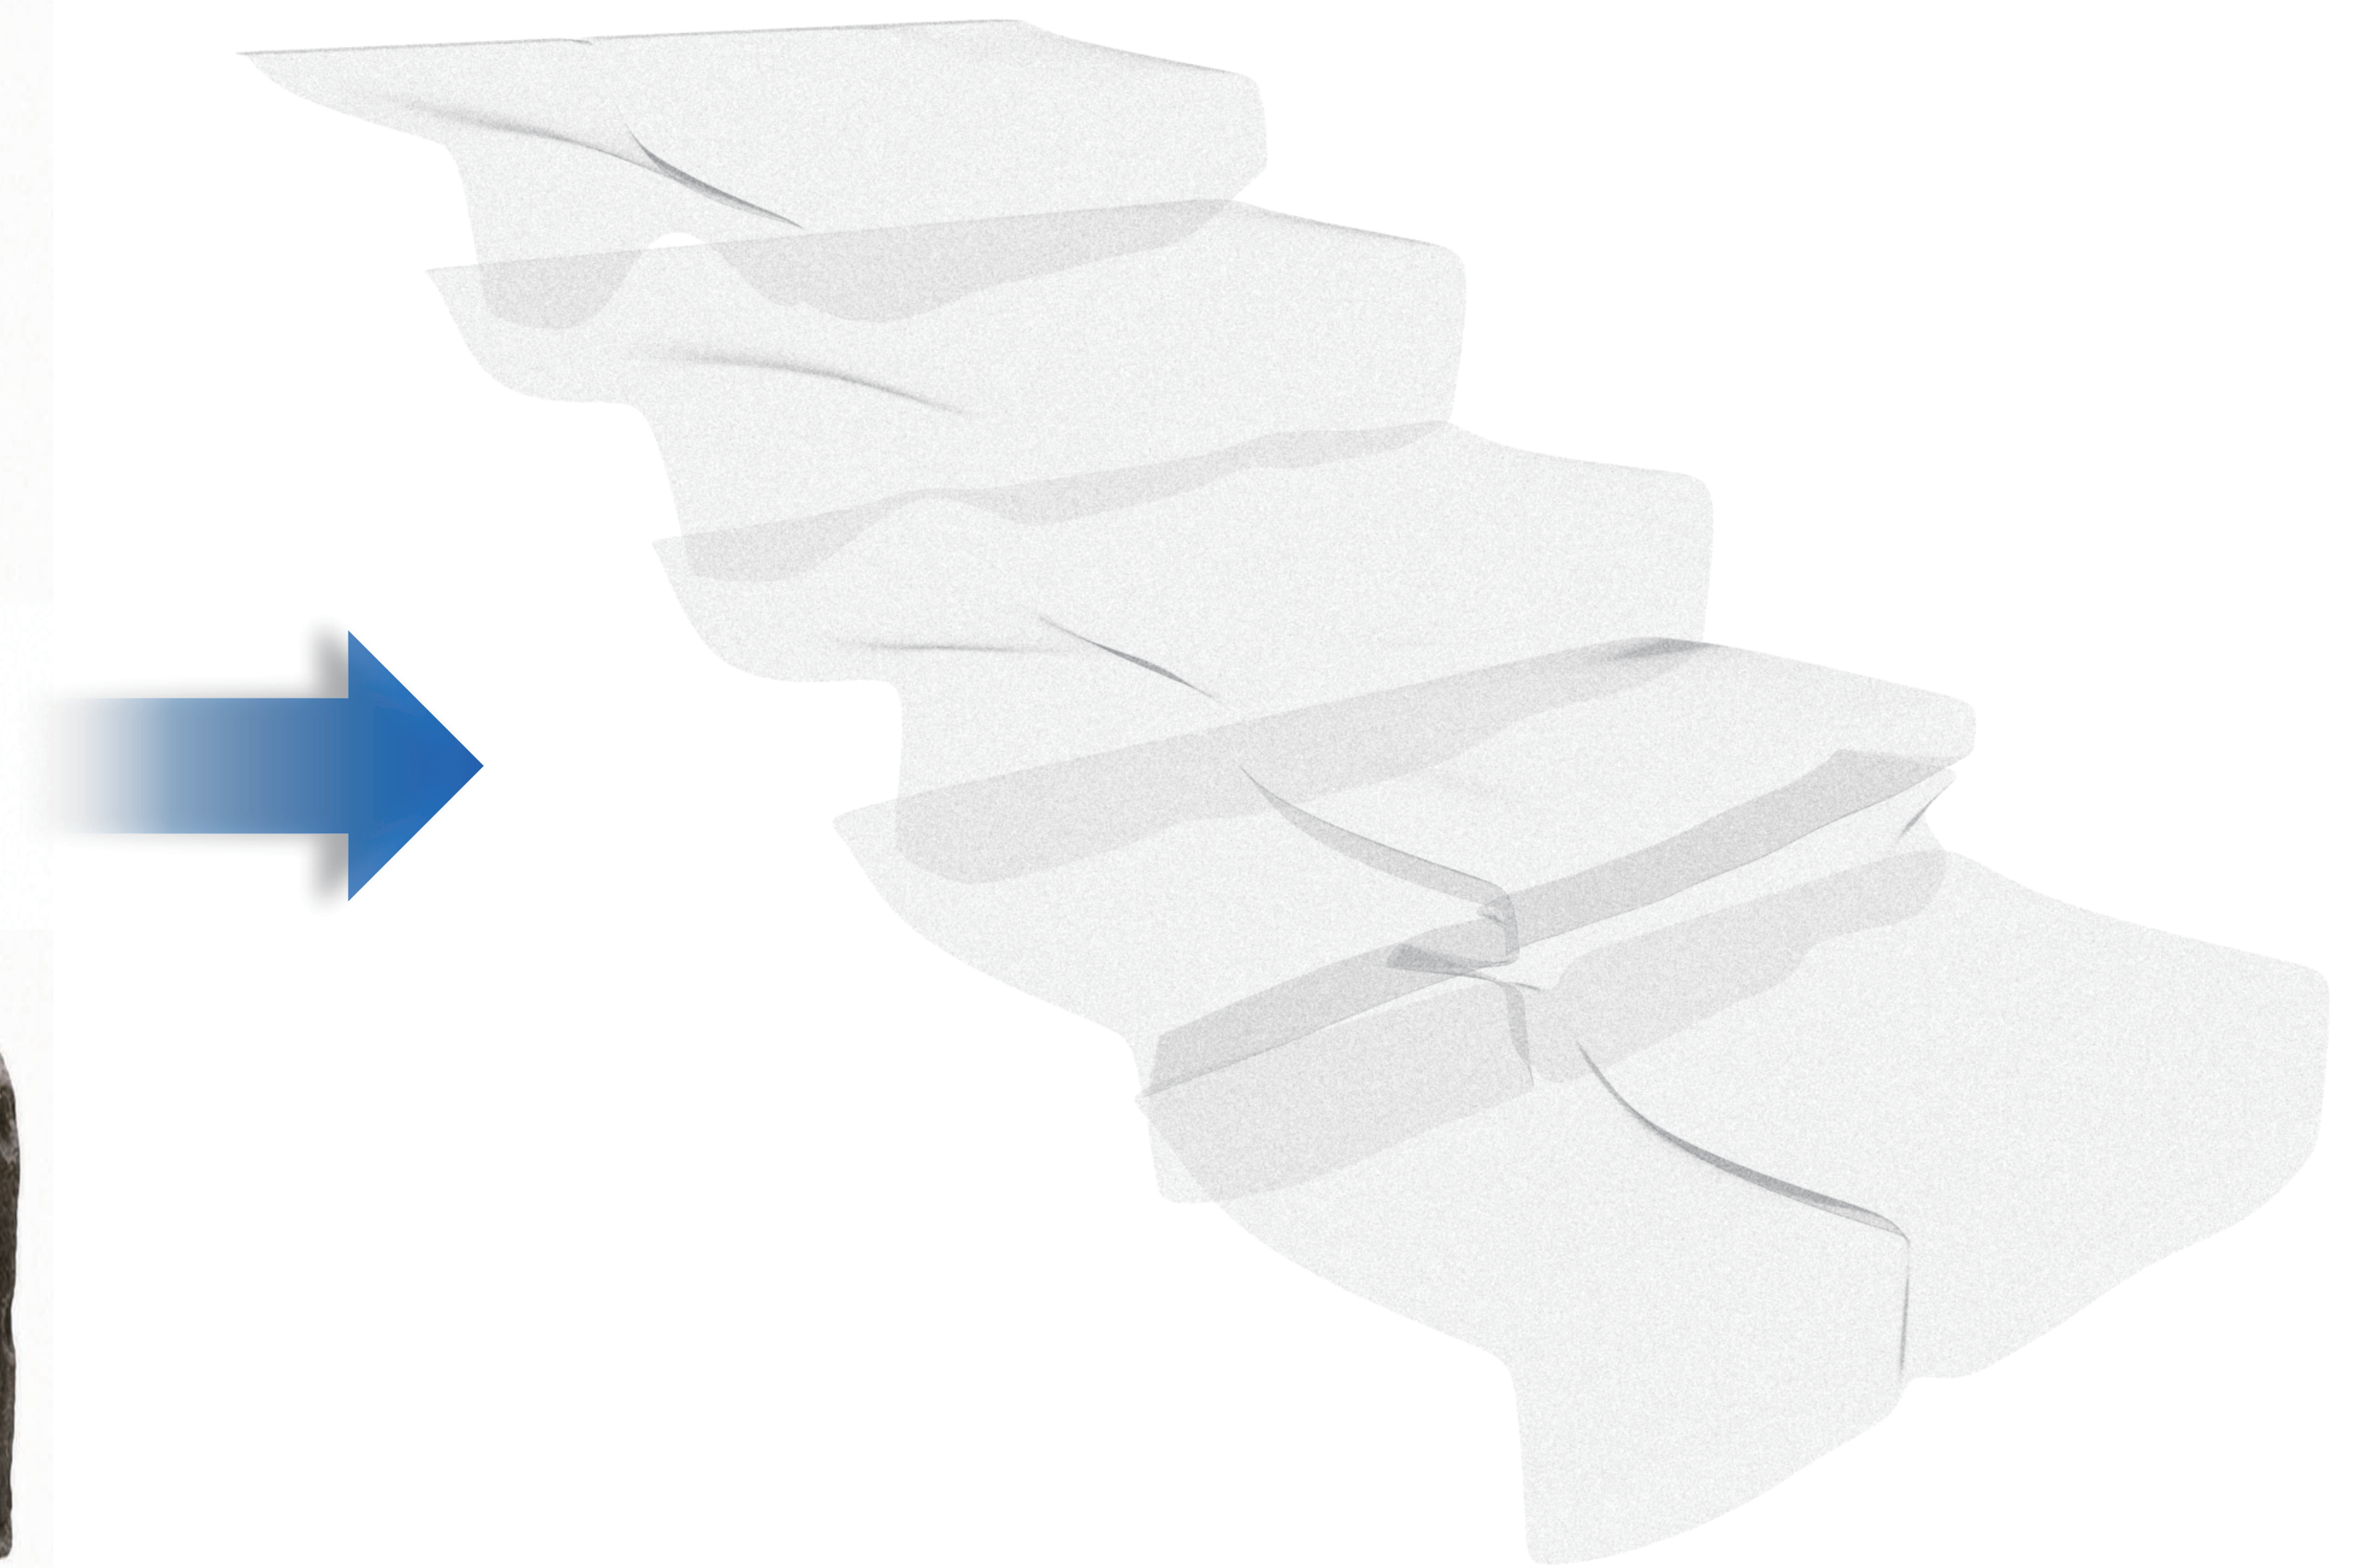
3D point-cloud scan

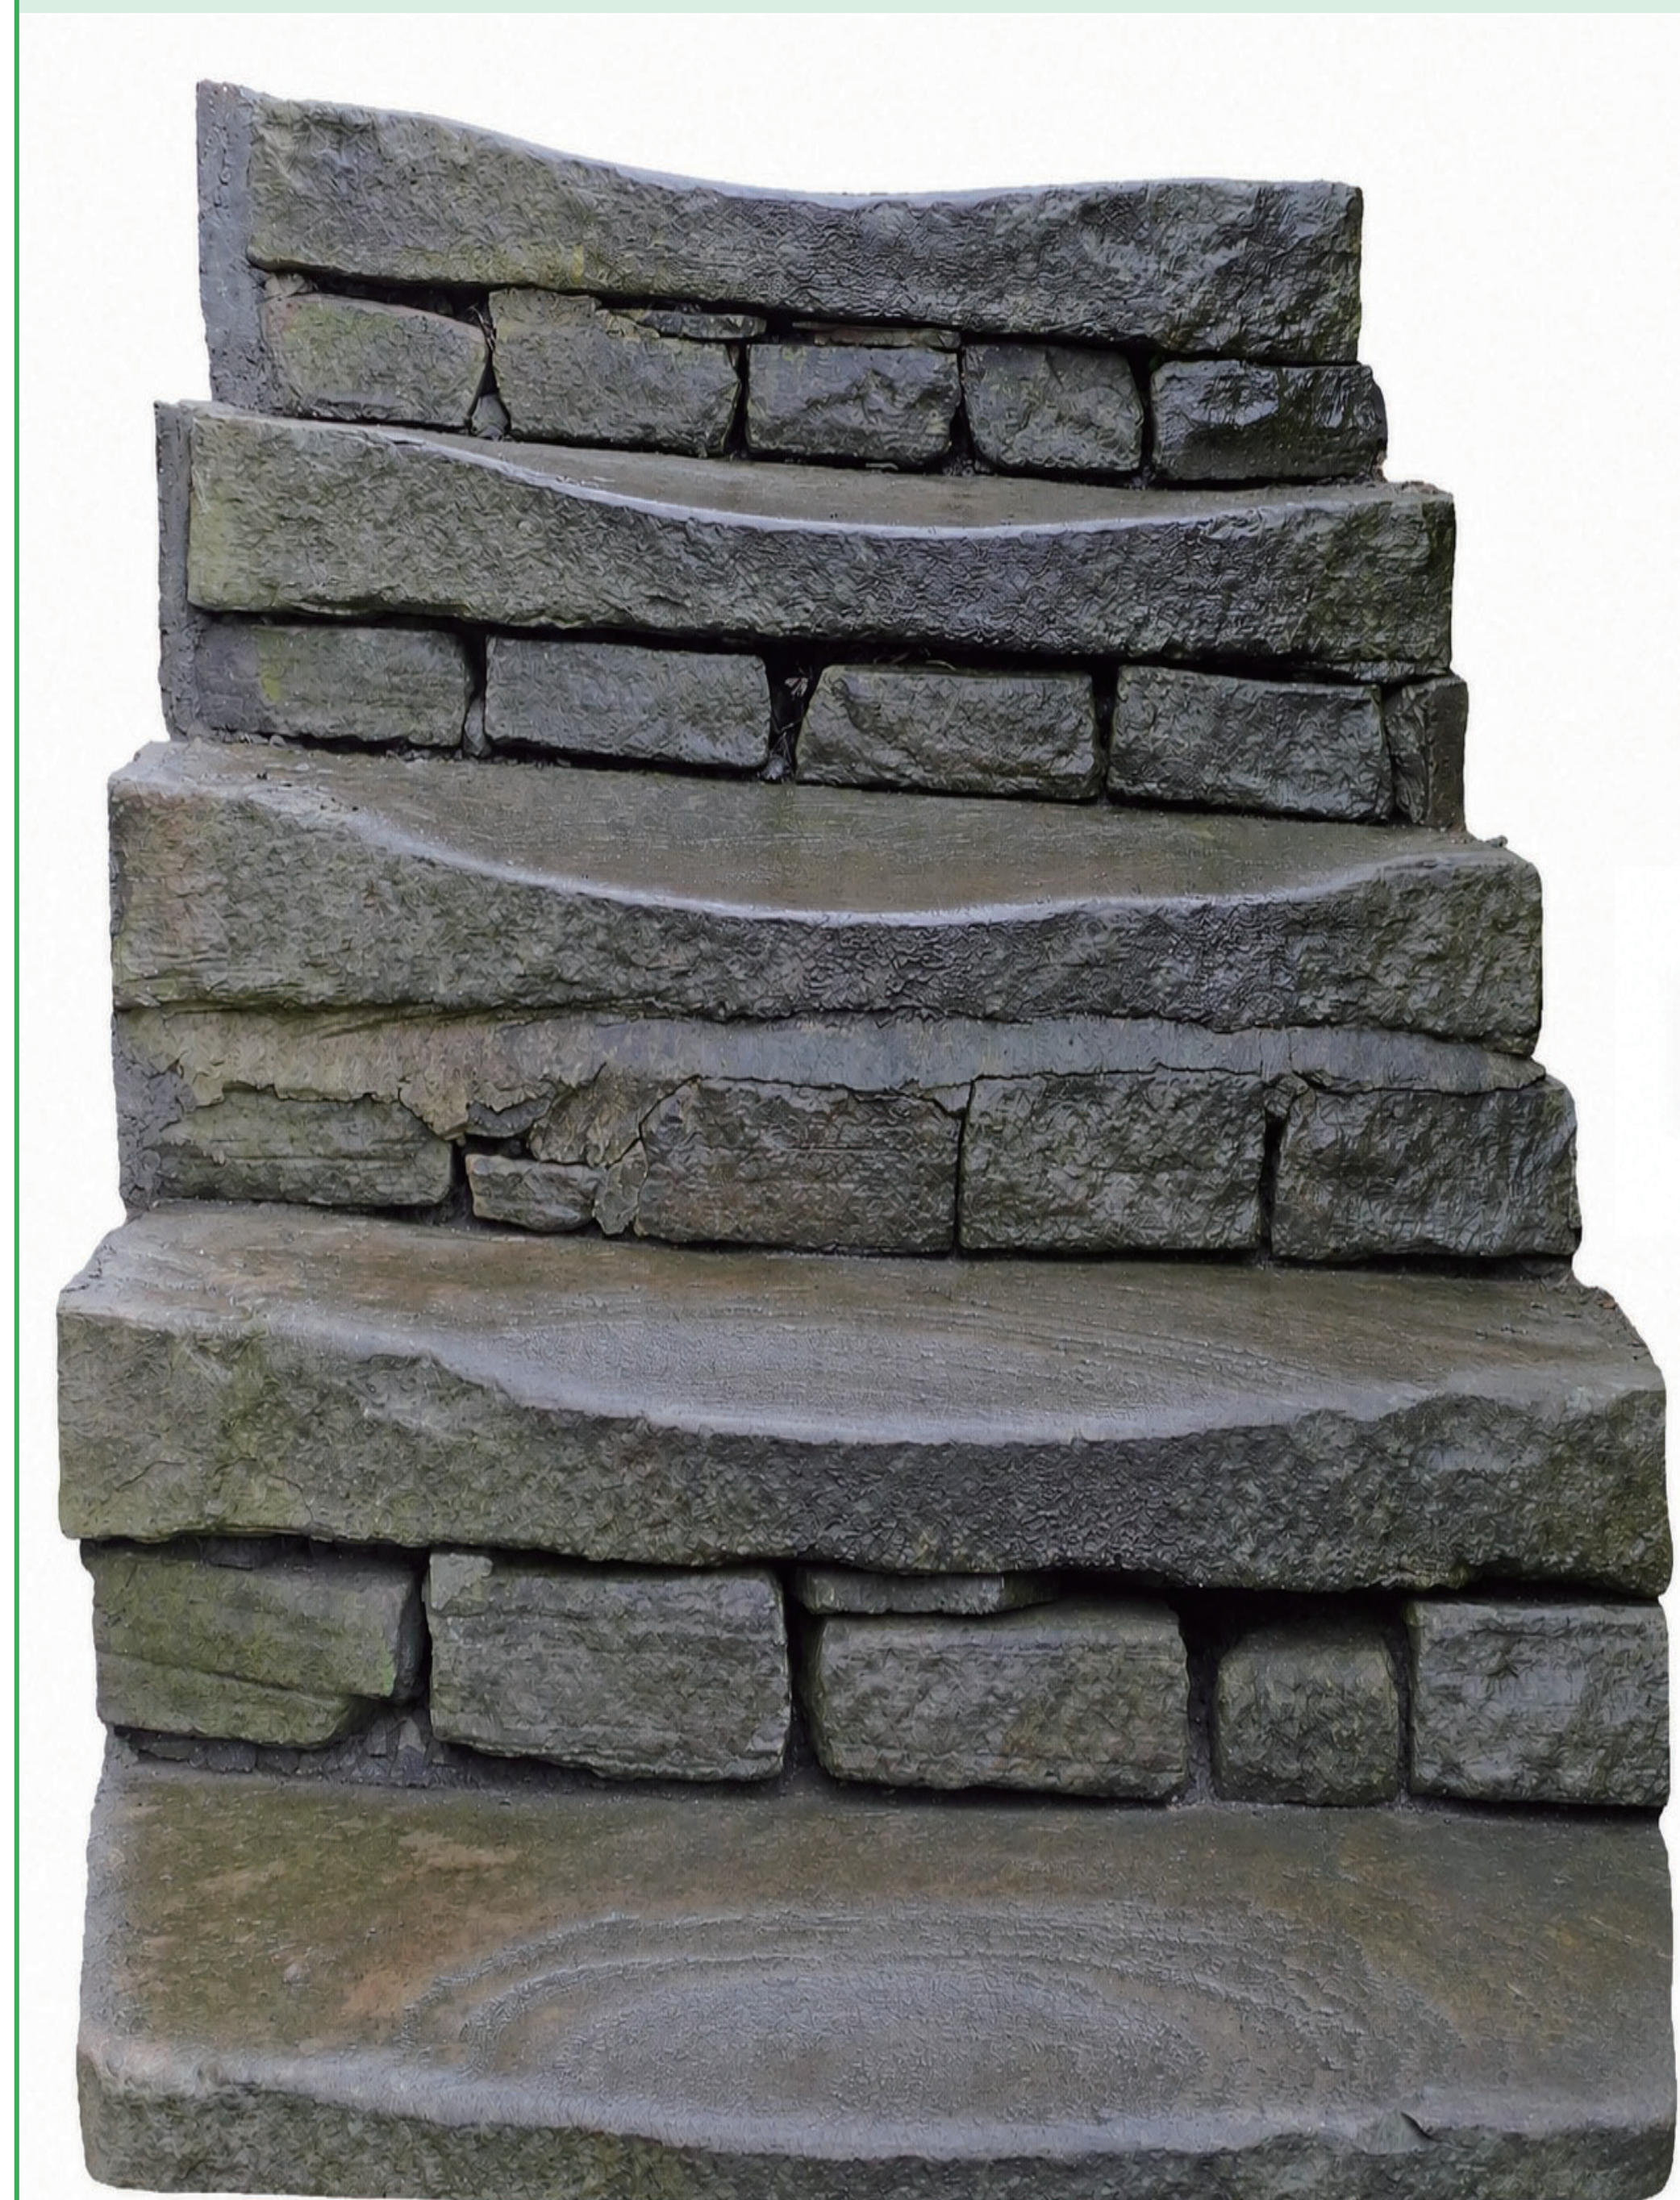
Staircase Number: No.3

### Block masonry steps with layered structure

Original image

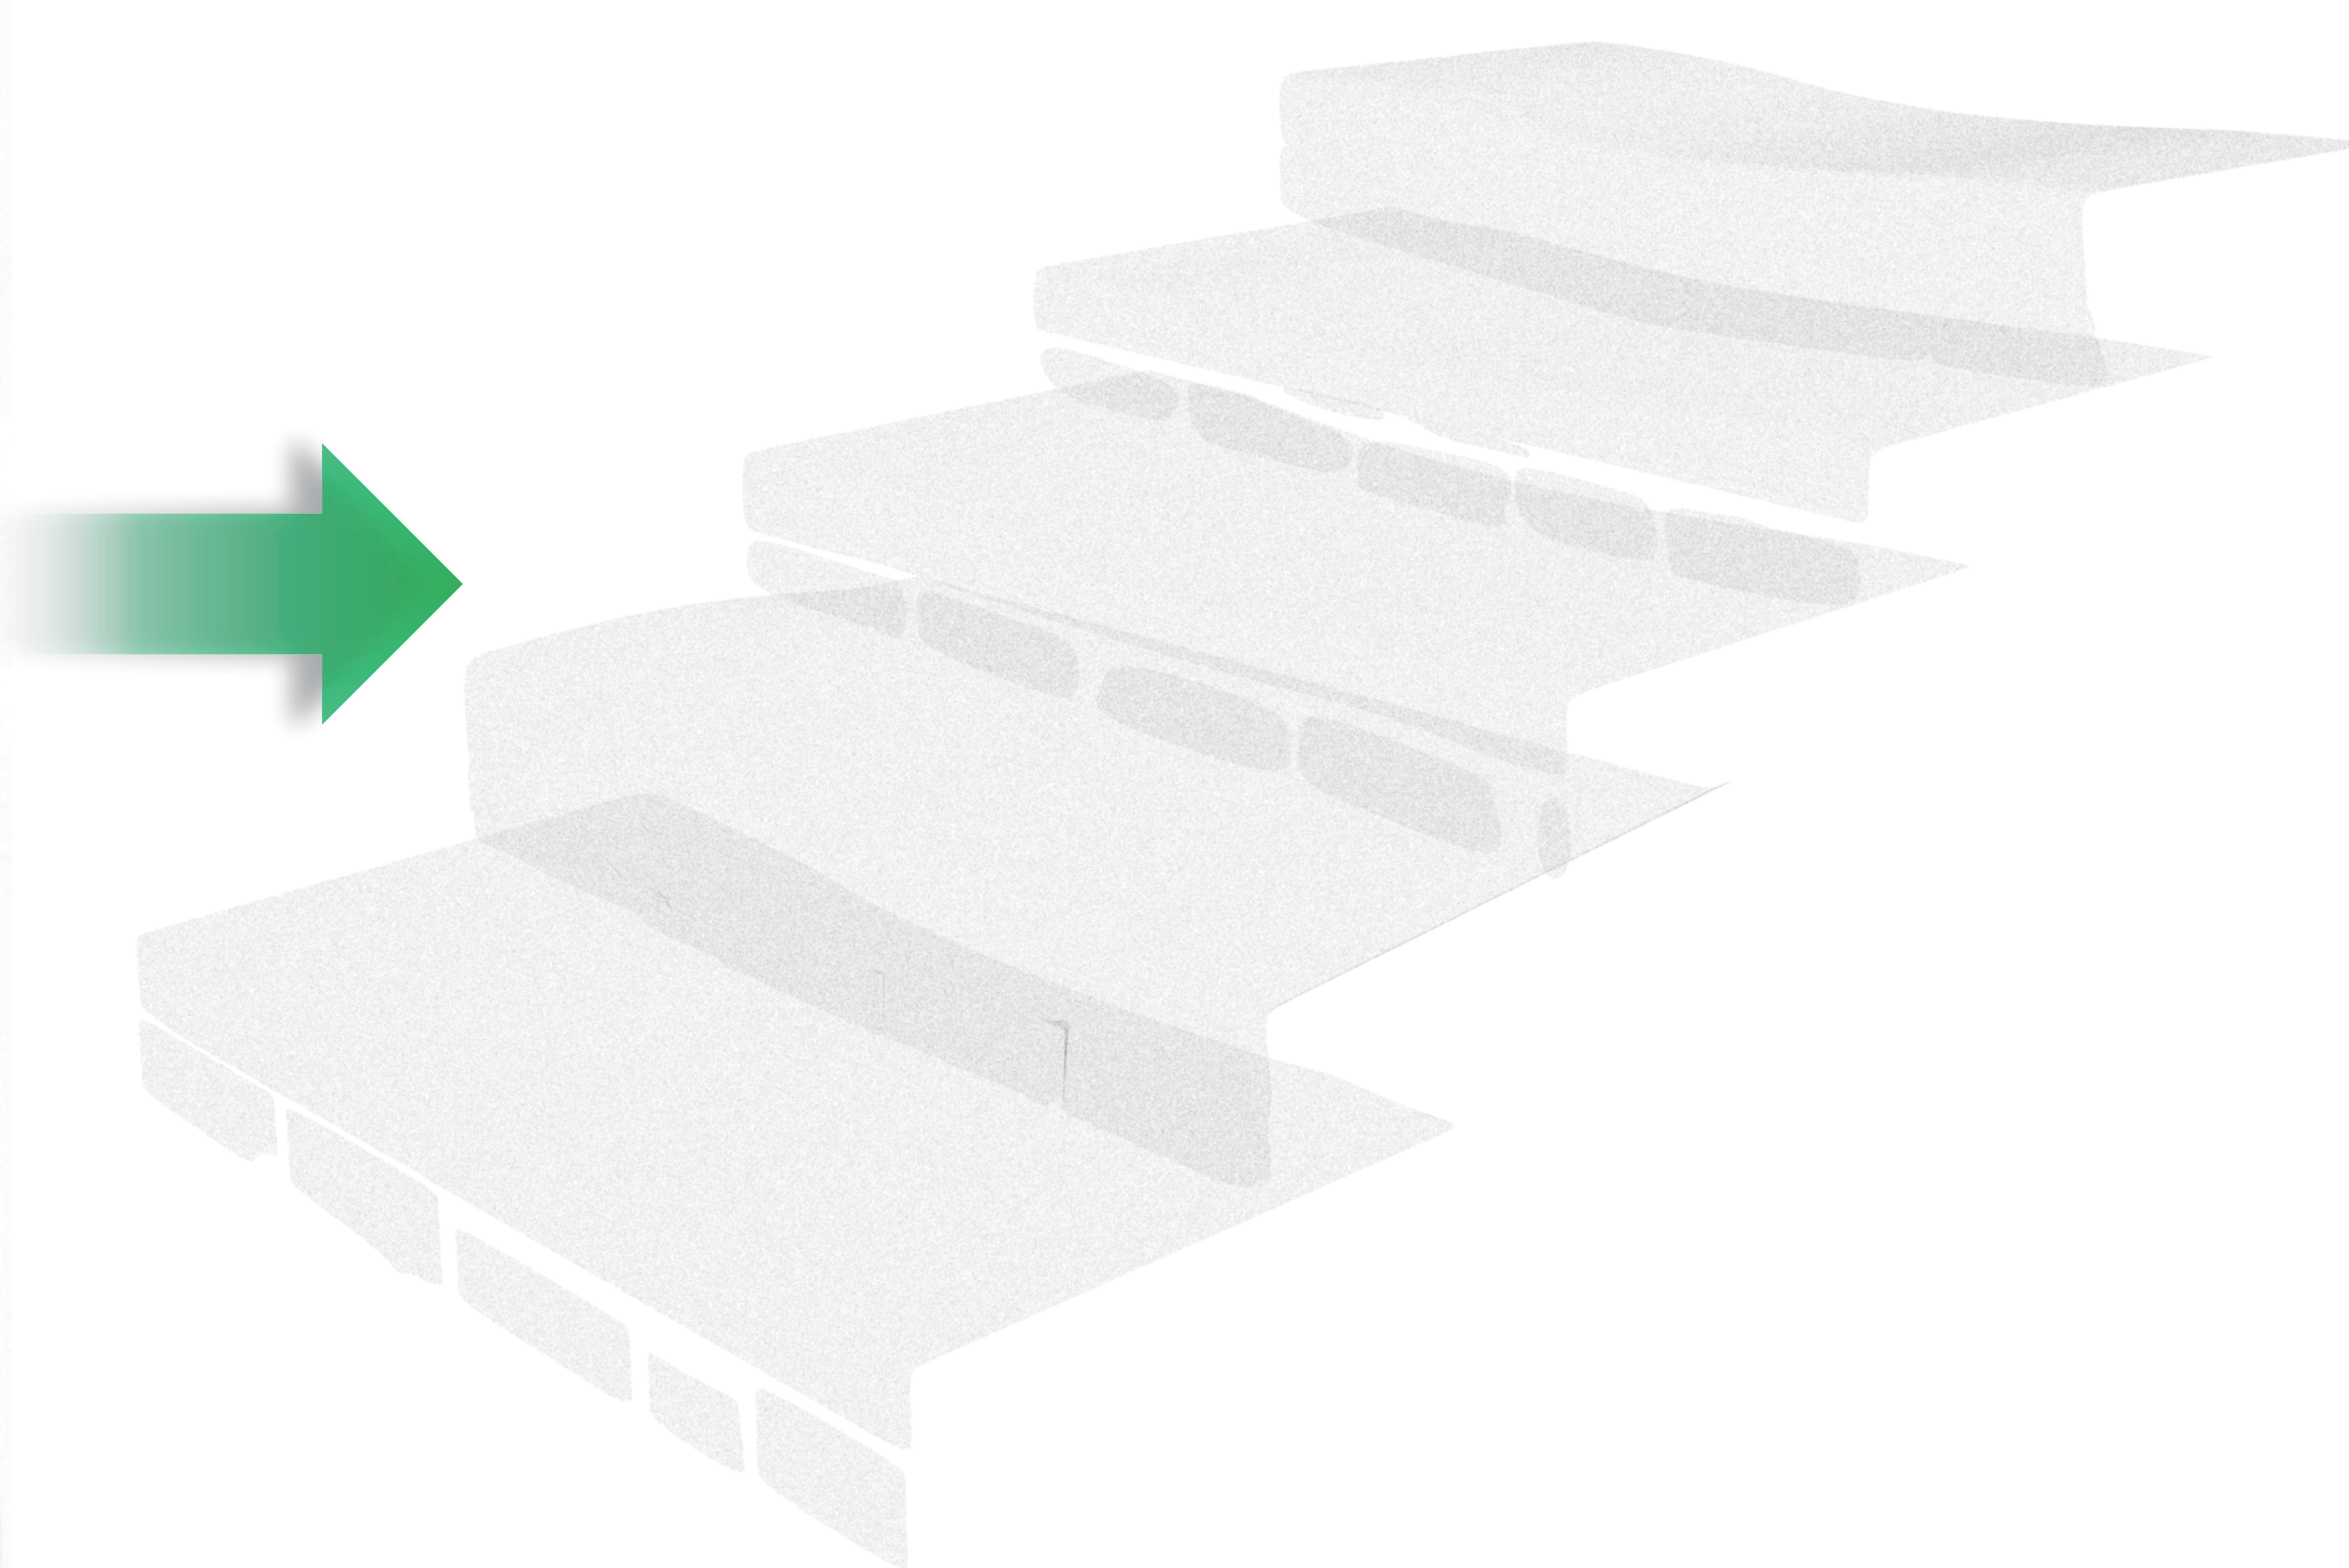
3D point-cloud scan
