### Weathered irregular stone steps

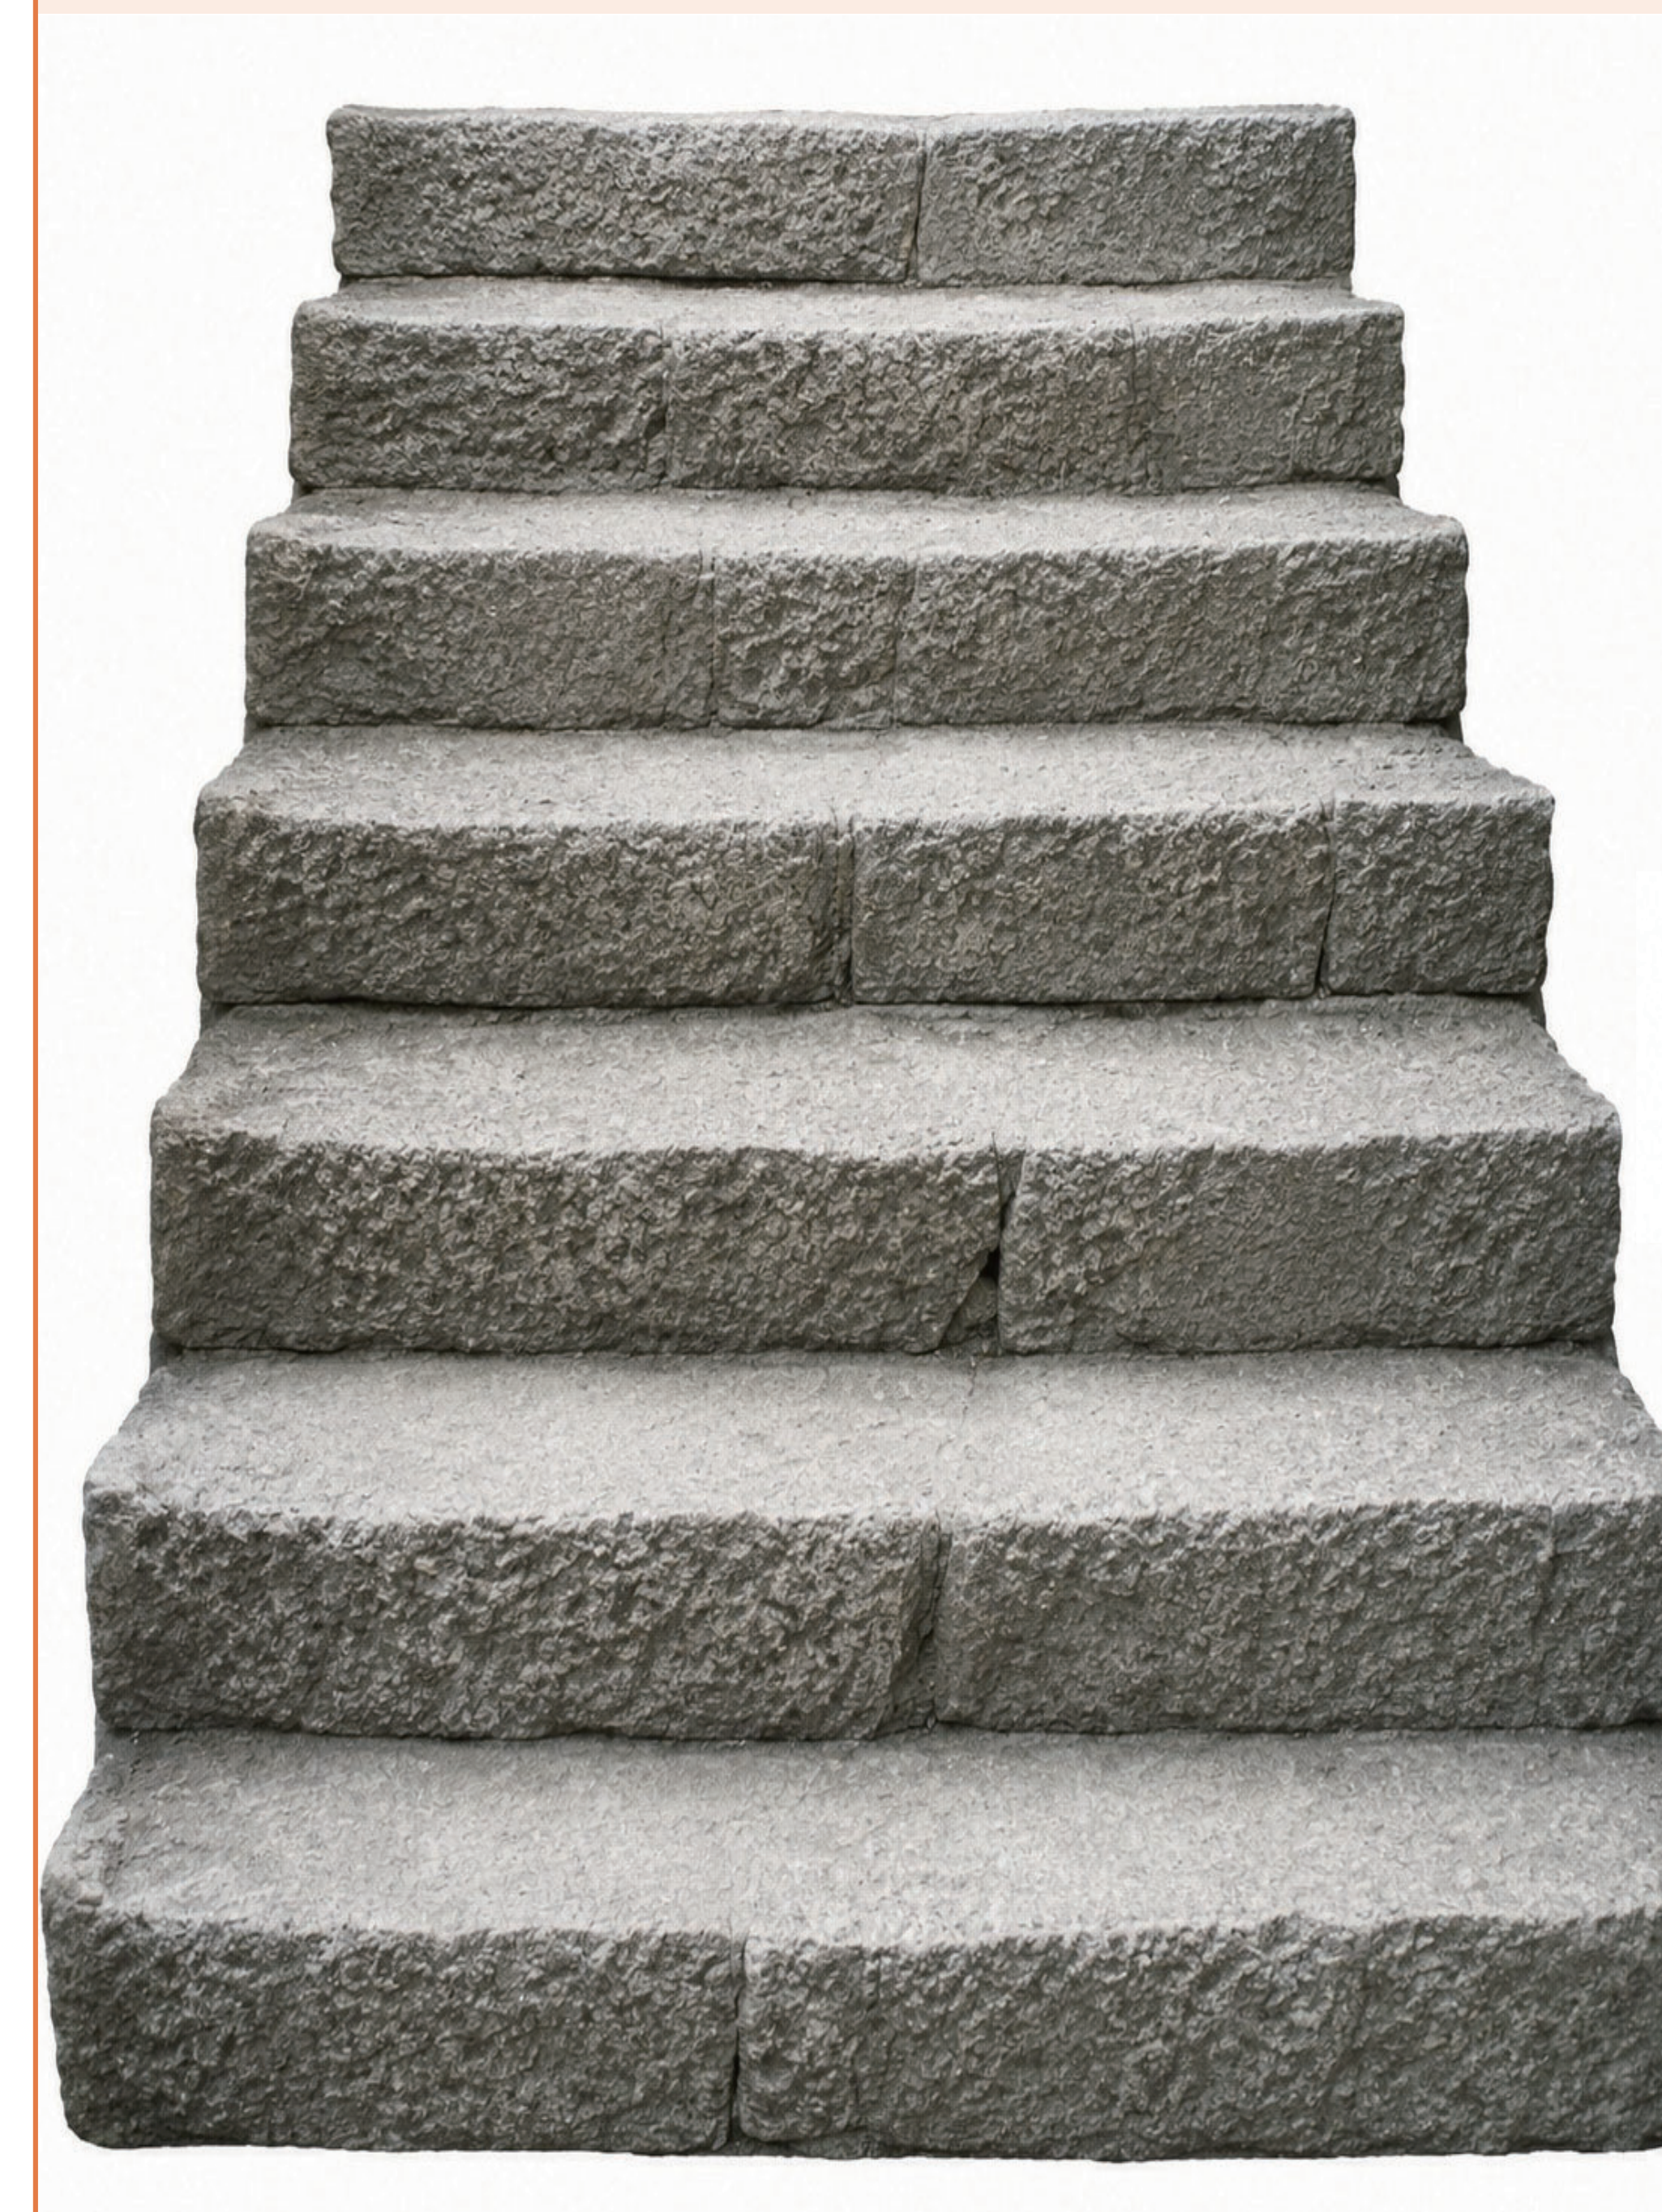
Staircase Number: No.4

### Regular granite stair steps with vegetation in joints

Original image

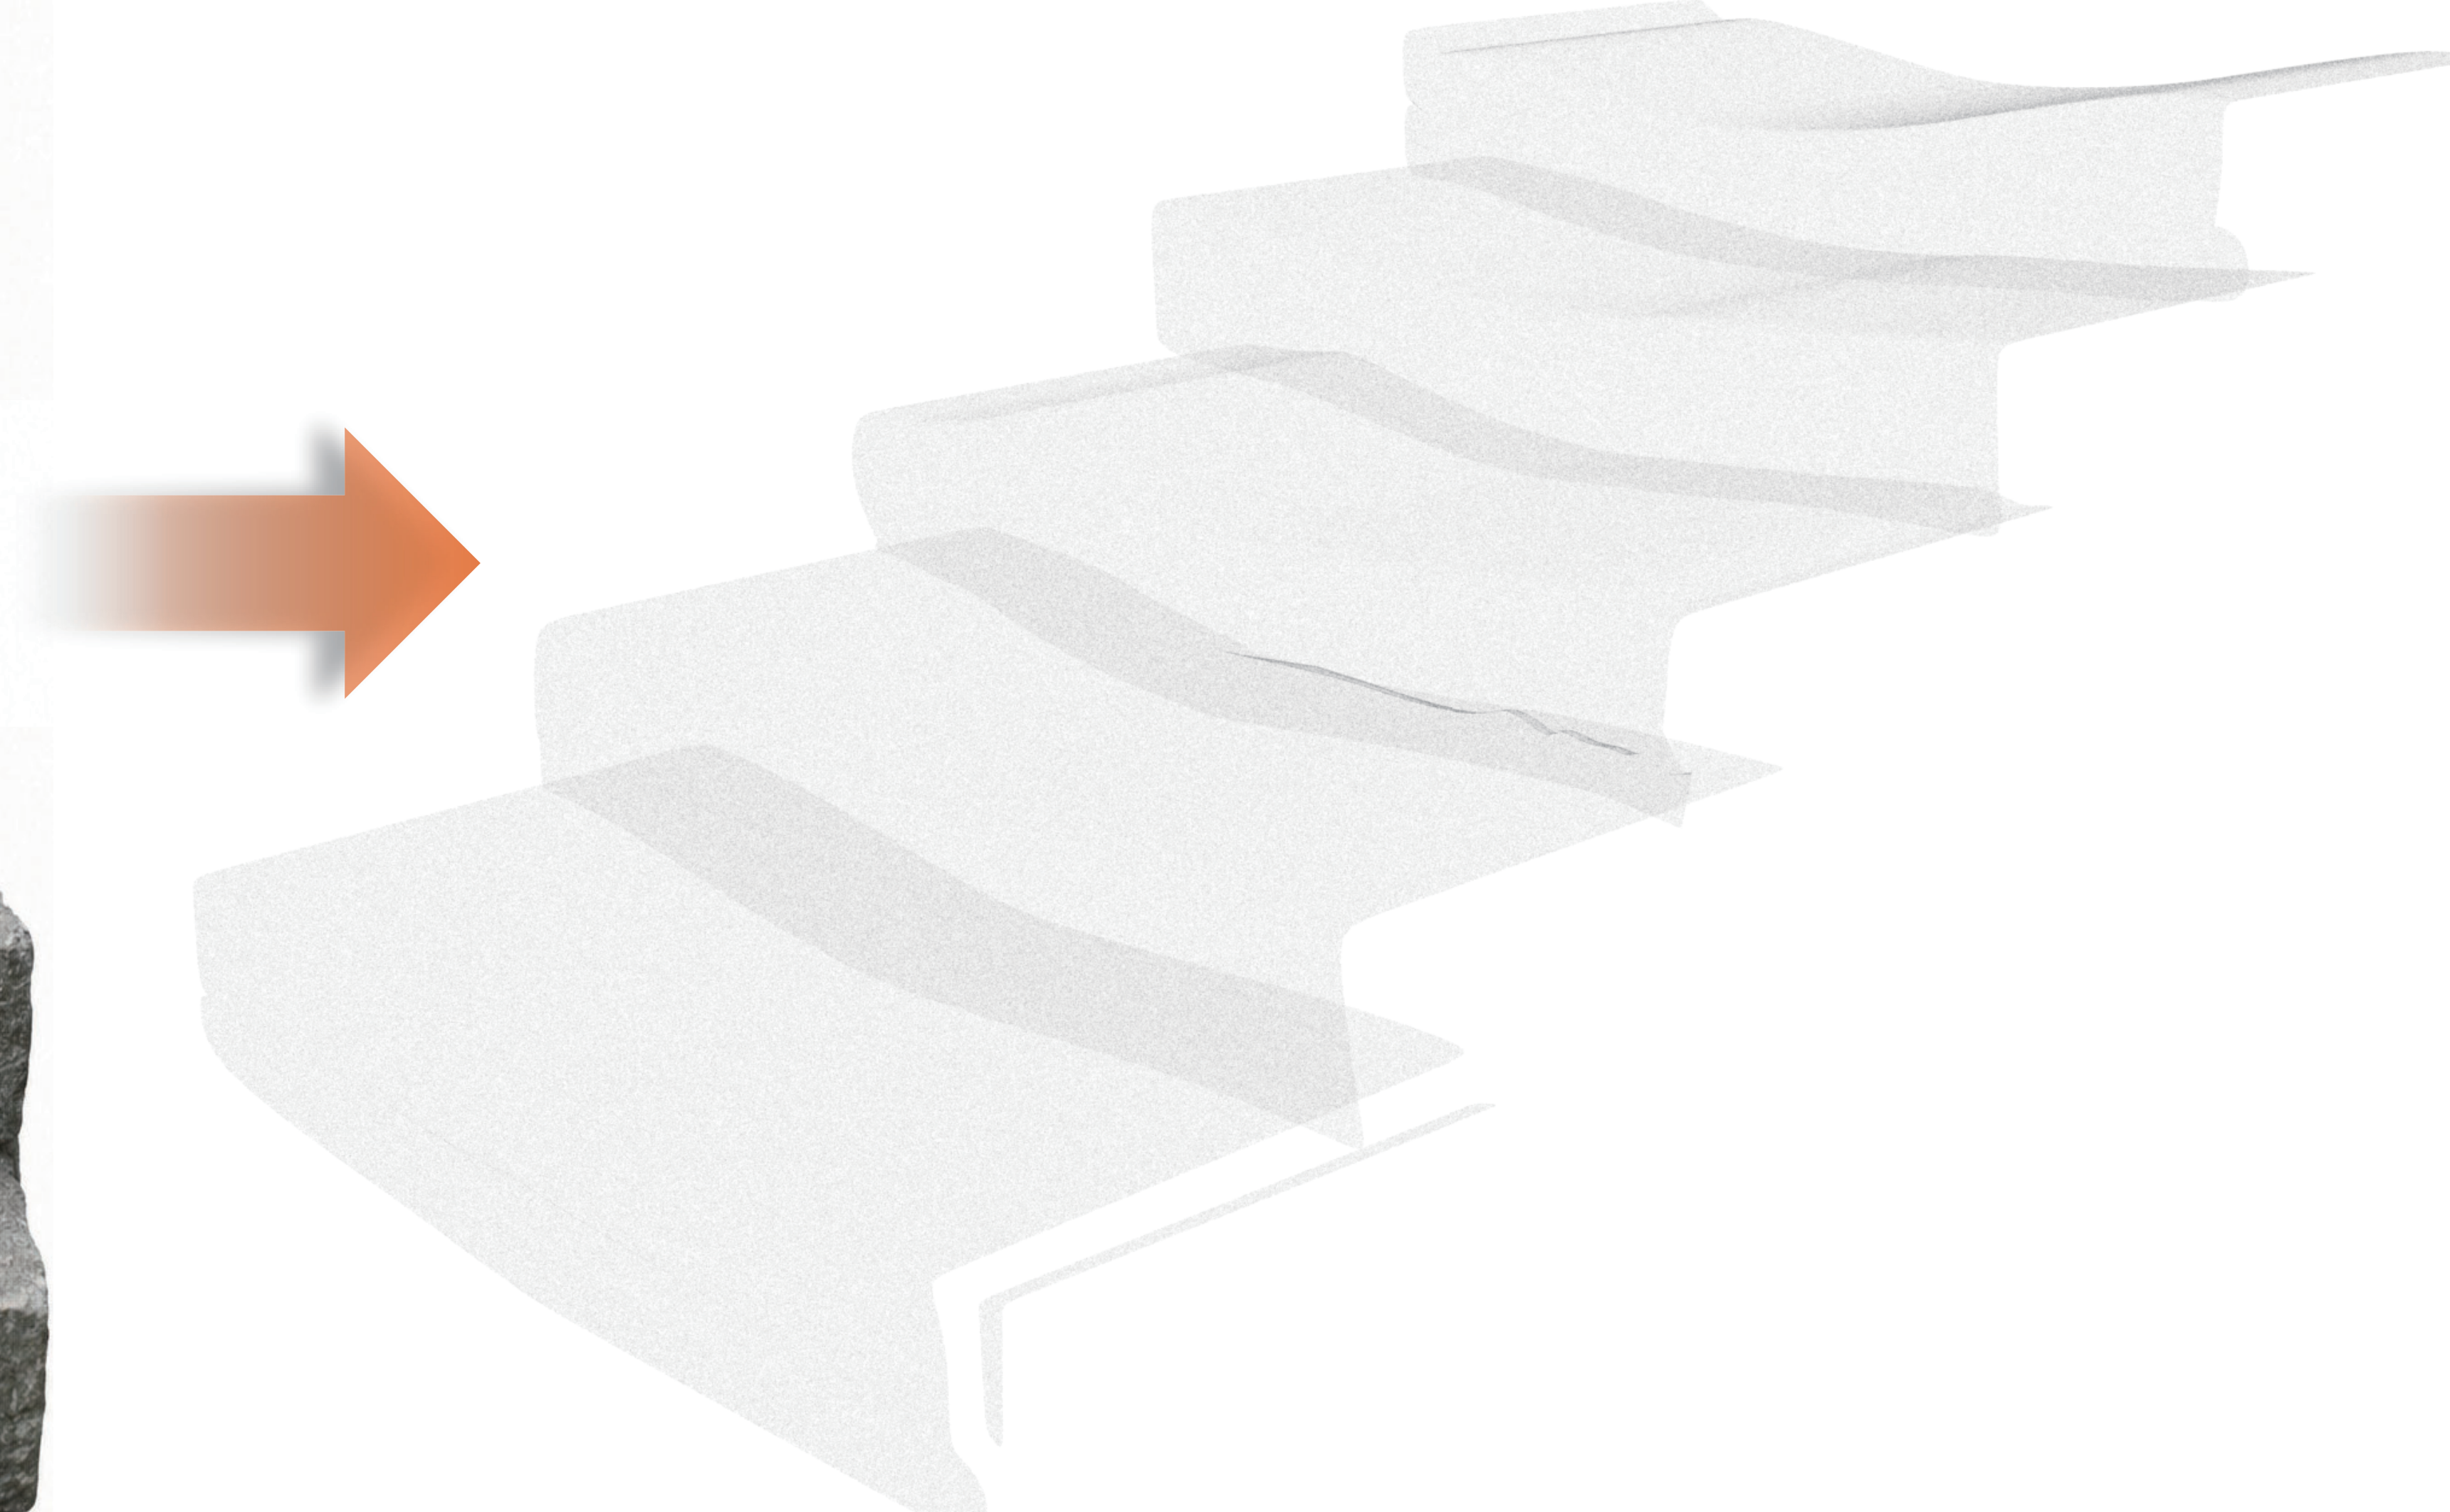
3D point-cloud scan
